## **About the mapping of reinforced concrete columns with pathological manifestations: Case in buildings belonging to the public university**

**Giovana Viscardi Fernandes<sup>1</sup>, Poliana Bai Naldo<sup>2</sup>, Cesar Fabiano Fioriti<sup>3</sup>.**

This work is a case study through the mapping of pathological manifestations identified in reinforced concrete pillars of buildings belonging to the Faculty of Science and Technology of UNESP (FCT/UNESP), located in Presidente Prudente, São Paulo. In the field, a survey of anomalies in the buildings under study was carried out using digital images. The information obtained was gathered and organized with the respective locations on campus of the images collected and captions that indicate the type of anomaly present – cracking, staining, detachment, exposure of reinforcement with corrosion or niche – by means of different shapes and colors. It was then analyzed, with the aid of a quantitative graph, that the types that appeared most frequently were exposure of reinforcement with corrosion, cracking and detachment, showing that maintenance and/or repair programs should be carried out.

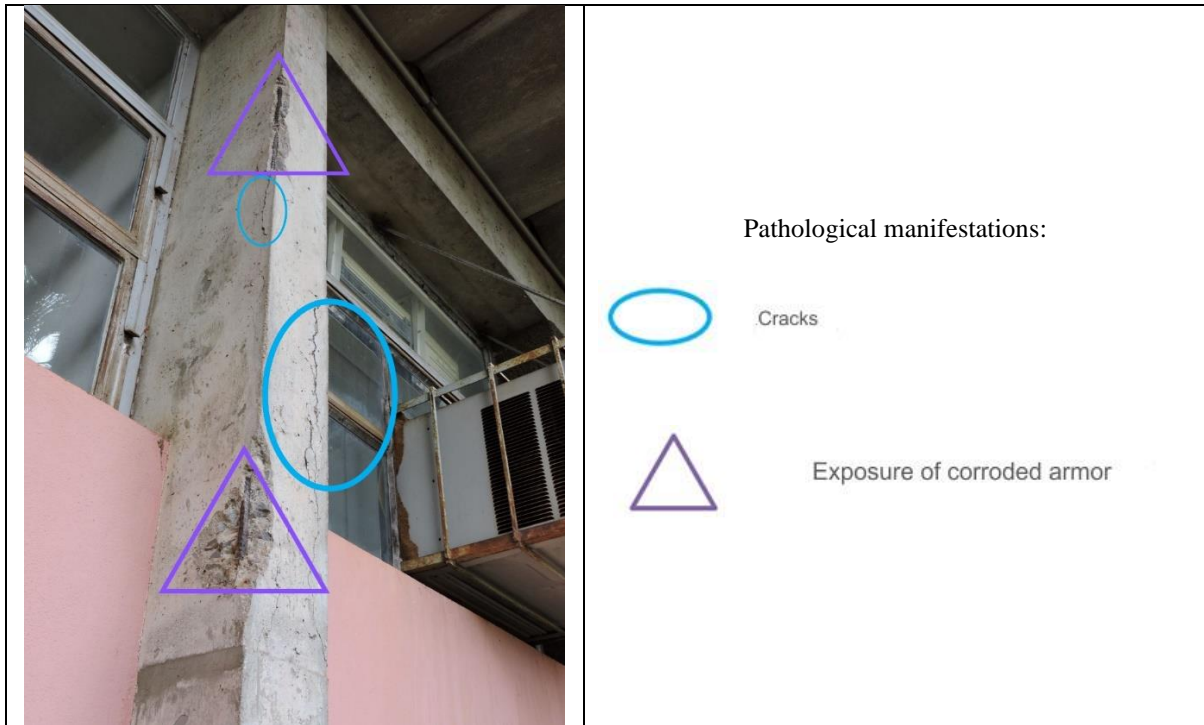
Table 5. Mapping of pathological manifestations – Department of Planning, Urbanism and Environment; Department of Cartography.

<p>Pathological manifestations:</p> <ul style="list-style-type: none"> <li>

Deplatformations</li> <li>

Exposure of corroded armor</li> </ul>
	<p>Pathological manifestation:</p> <ul style="list-style-type: none"> <li>

Cracks</li> </ul>
	<p>Pathological manifestations:</p> <ul style="list-style-type: none"> <li>

Exposure of corroded armor</li> </ul>

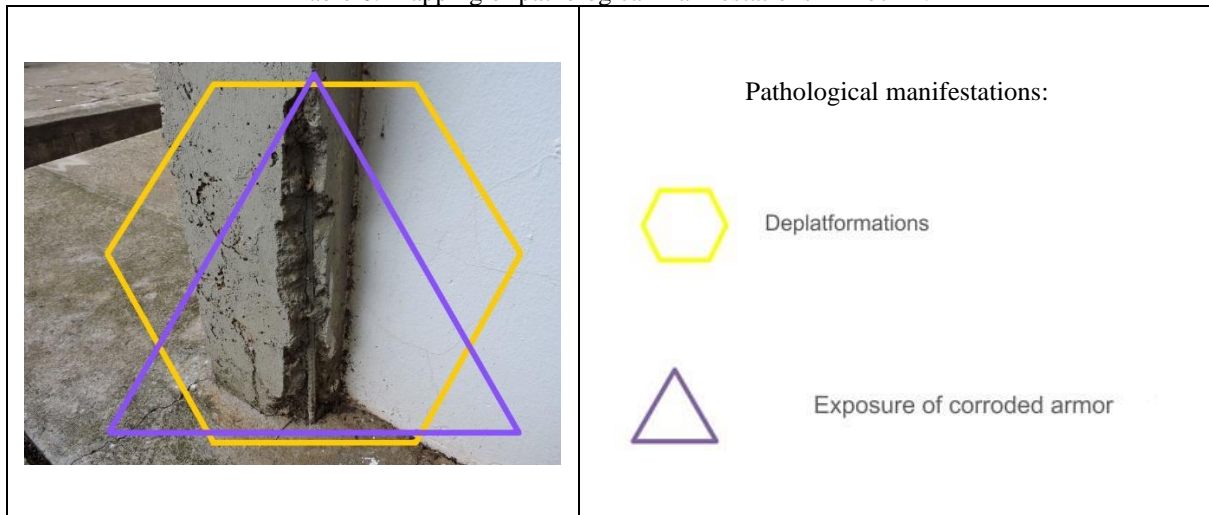
Table 6. Mapping of pathological manifestations – Block 2.

Finally, in Block 2, we have the following occurrences:
