Study of the effectiveness of constructive methods through the evaluation of the surface using the LVC method: Case study of the Antônio Carlos Belchior highway in the city of Sobral, CE

of permanent investments in the construction, maintenance, and inspection of highways. The present research work had as its main focus to evaluate the surface conditions of the pavement of a highway using a Continuous Visual Survey Method. For this purpose, a comparative analysis was carried out between the project of the enterprise and its execution, as well as the pathologies presented as a result of its use. The studied highway, named Av. Antônio Carlos Belchior, is located in the city of Sobral, Ceará, Brazil. For the evaluation of the surface of the pavement, the Norm DNIT 008/2003 - PRO was adopted, where the required conditions for the accomplishment of the evaluation of the surface of flexible and semi-rigid pavements are fixed. During the work, the pathologies present in the pavement were detected and classified according to the characteristics presented during the evaluation. Therefore, in this work, an approach was carried out from the elaboration of the project to the execution of the

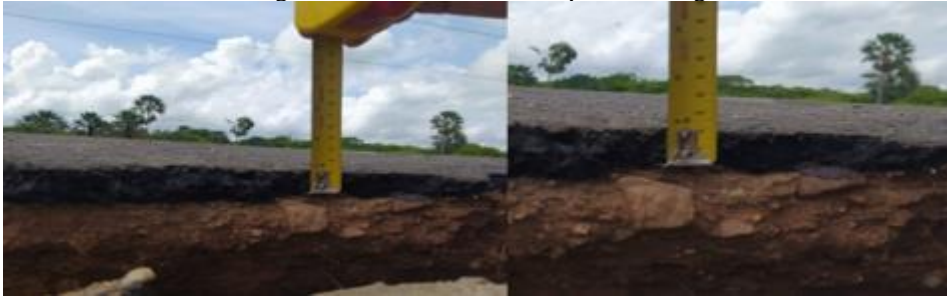
Figure 4. The thickness of asphalt coating

According to the dosage design, the coating should be 5 centimeters thick. However, according to Figure 3, this thickness was reduced to 2 centimeters. Based on this analysis, the thickness of the pavement may be the cause of the defects presented on the paving surface. Cracks were observed throughout the analyzed segment. Figure 5 illustrates some pathologies present in Segment 1.

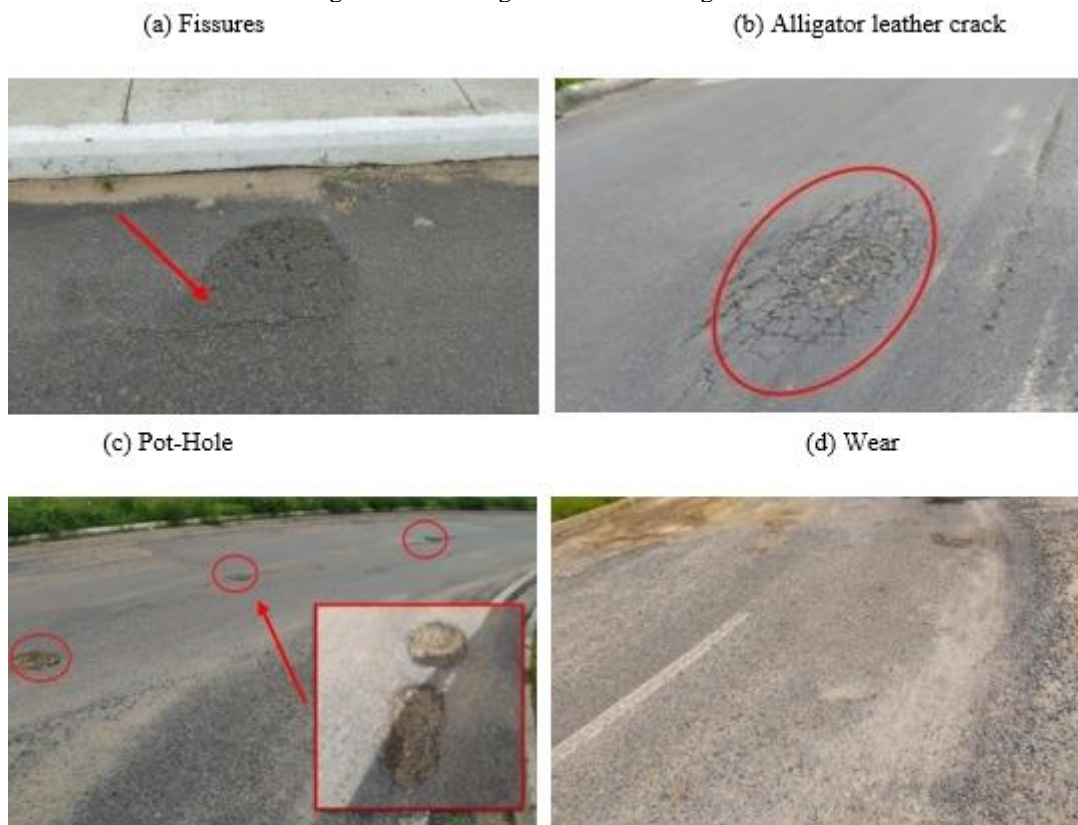
Figure 5. Pathologies observed in segment 1.

As shown in Figure 5a, these cracks were partially maintained after the coating layer was executed. These cracks are positioned longitudinally to the axis of the highway, presenting as possible causes of the poor dosage of the asphalt coating or excessive compaction or at an inappropriate time.

Figure 5b shows an interlocking crack like alligator leather accompanied by wear of the pavement, having as possible causes, the collapse of the asphalt coating due to the repetition of the actions of the traffic and poor quality of the structure or one of the layers of the pavement, low capacity of support of the soil.

Defects such as pot/holes were also detected in the segment both at the entrance to the roundabout and at the roundabout itself, as shown in Figure 5c. These types of defects can be caused by fatigue cracks, localized disintegration on the surface of the pavement, deficiency in compaction, excessive moisture in soil layers, and Print failure.

The observed wear and tear are largely present on the highway in general. Figure 5d illustrates this type of defect present in segment 1. This type of pathology, in general, is linked to adhesive failures between the binder and aggregate, deficiency in the binder content, and executive or mixture design problems.

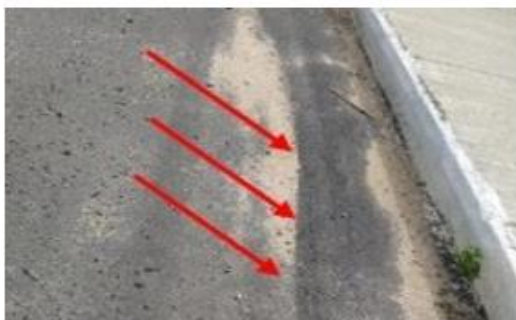
(a) Plastic sinking

Figure 6a shows a defect detected along segment 2. It is a plastic wheel track sinking. This type of sinking consists of a permanent deformation of the surface of the pavement, accompanied by a lateral volumetric compensation (lifting) that is indicated by the arrows in red. This defect can be caused by the plastic creep of one or more layers of the pavement or subbed, or failure to select the type of asphalt coating for the requesting load.

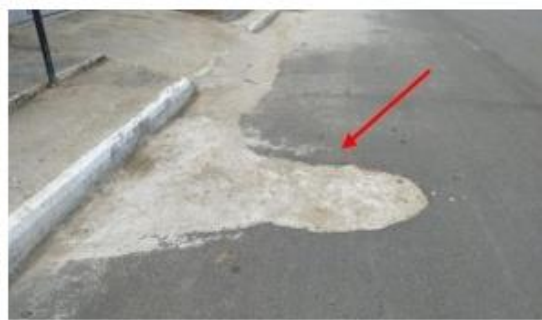
(b) Deep patch

Figure 6b is a deep patch due to sewer installation after paving is done. This type of installation should be done before any layer of the pavement, to avoid future pathologies and structural damage to the pavement. As it is a deep patch, there must be a replacement of the coating and, eventually, of one or more lower layers of the pavement. Thus, the cause of this pathology may have been caused by improper construction or management in the execution stage.

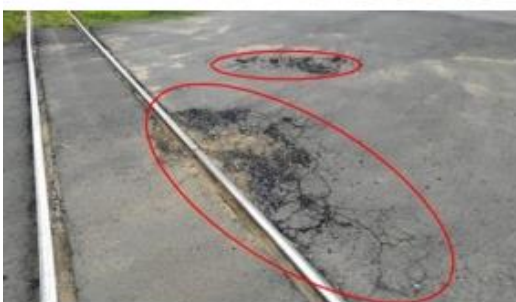
(c) Alligator leather cracks

Figures 6c show interlocking alligator leather cracks. These defects were detected at various points on the highway. Nonetheless, the most prominent is located at the intersection of the highway and the railway. The interlocking cracks like alligator leather, are considered a structural defect caused by the collapse of the asphalt coating due to the repetition of traffic actions, inferior quality of the structure or one of the layers of the pavement, and/or low capacity of soil support.
