Chapter 56

Inspection of pathological manifestations and map of damage on facades: case study in "Block C" of the polytechnic school of Pernambuco

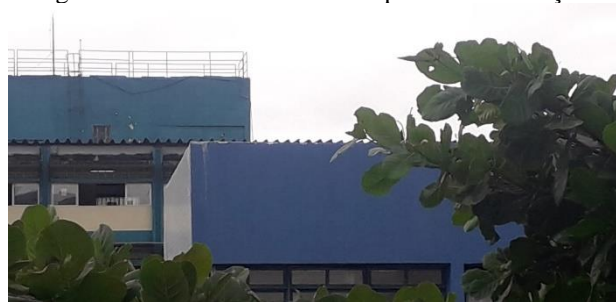
According to Ribeiro (2018) [12], efflorescence is a pathological manifestation formed by the saline deposit in the coating, after exposure to water, whether from infiltration or weather, it is worth mentioning that in some cases these salts can cause a deep degradation. In addition to the lack of maintenance, since it is an area at the top of the building, the difficult access can be the cause of this (Figure 2).

Figure 2 - Efflorescence at the top of the front façade

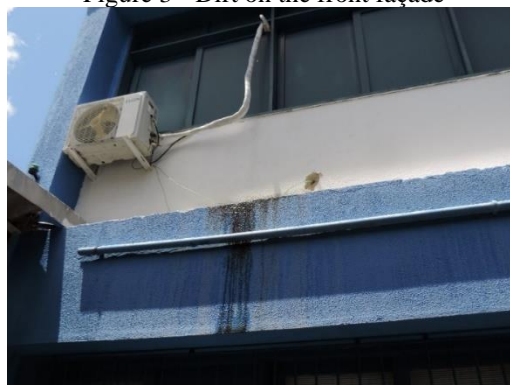
The façade presents dirt at specific points, mainly near the water outlet of the air conditioning drains (Figure 3). This pathological manifestation happens due to the accumulation of water that flows, constantly, leaving dirt particles in the route.

Figure 3 - Dirt on the front façade

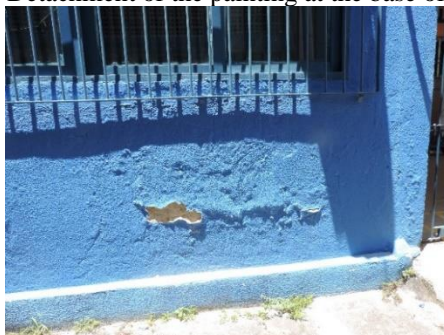
And some points, presented detachment of painting at the bottom of the structure (Figure 4), but also near some windows on the upper floors (Figure 5). The presence of moisture is the possible cause of detachment in the lower region of the façade, but in the vicinity of windows, the wrong choice of material may have caused this pathological manifestation.

Figure 4 - Detachment of the painting at the base of the façade

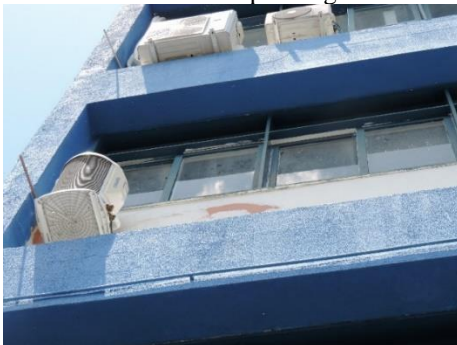
Figure 5 - Detachment of the painting near the windows

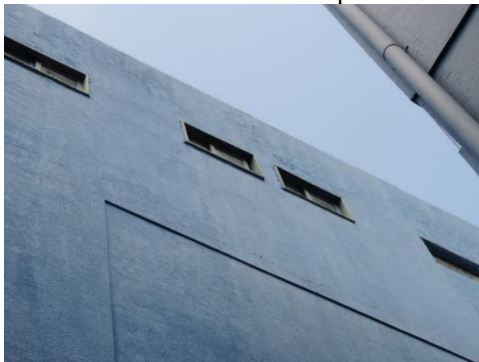
As you can see in Figure 6, a horizontal fissure is noted in the upper region of the façade. This fissure can be observed throughout the length of the façade, it is highlighted that the sun before reaching part of Block C, reaches Block J that is ahead, that is, this fissure can be due to the distinct thermal dilation between the part that receives the sun directly and the part that is in the shadow of Block J.

Figure 6 - Horizontal fissure at the top of the front façade

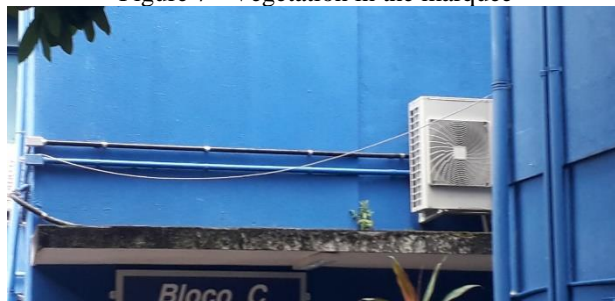
In addition, vegetation was found on top of the marquee (Figure 7) in which the plaque with the name of the block is found, this is due to the difficulty of visualizing the area and the lack of regular maintenance.

Figure 7 - Vegetation in the marquee

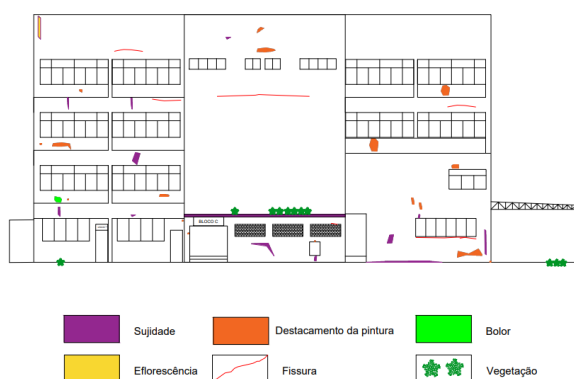
Figure 8 - Front façade damage map

Elaborated on the front façade of block C, the damage map (Figure 8) represents the current situation of the façade seen according to the inspections carried out, it should be noted that the block presented underwent the last maintenance on 29/11/2019, with painting, according to engineer Otávio Wilson who was one of the responsible for monitoring. Through this map, it is possible to perceive the dirt points, the regions most affected by the detachment of the painting, the cracks found, as well as the few areas with mold and vegetation.

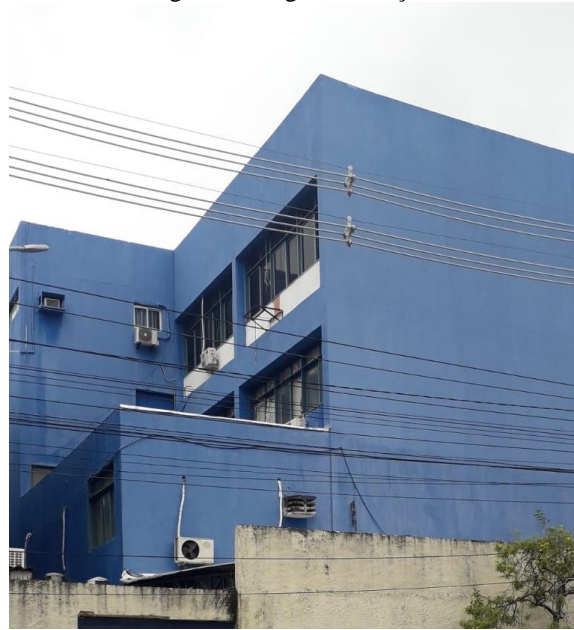
Figure 9 - Right side façade

It was identified that the two side facades present few pathological manifestations since Block C has recently undergone maintenance, as previously mentioned, reputed with painting, the right (Figure 9) is dirty due to the humidity resulting from the air-conditioning drains that allow water to flow, as observed in the damage map (Figure 10).

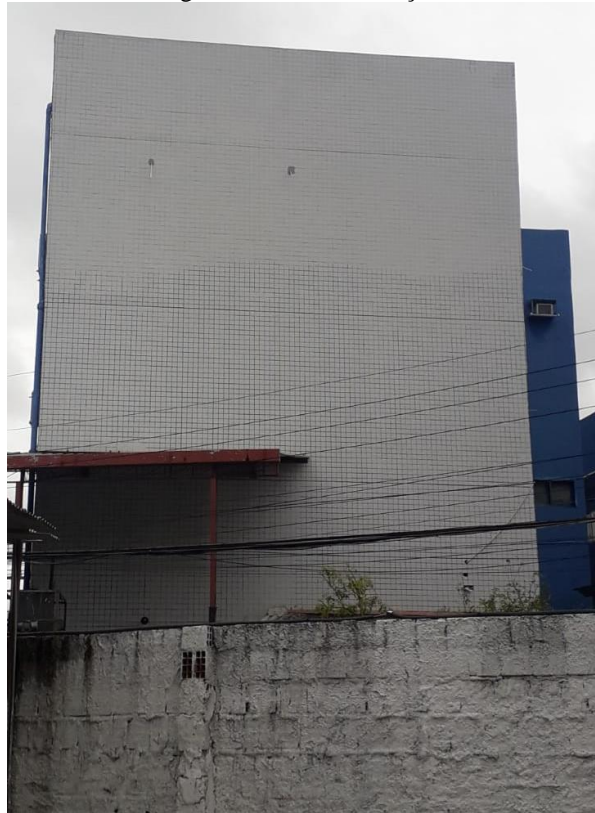
Figure 11 - Left side façade

The left side façade (Figure 11) has a stretch of ceramic cladding, where it was possible to observe two points of ceramic detachment, due to the openings through which the air-conditioning drains come out and a lot of dirt on the side of the marquee as can be observed on the damage map of this façade (Figure 12).

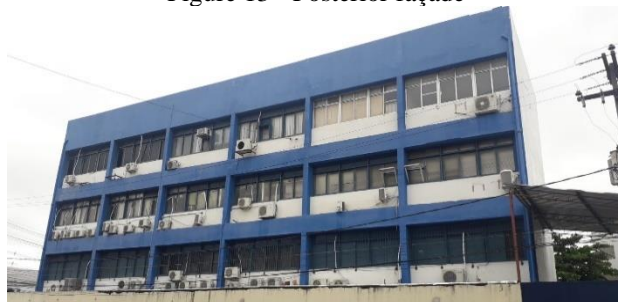
Figure 13 - Posterior façade

The back façade of Block C (Figure 13) has only one access to the block, which is not used by the students. It draws attention to points of the detachment of paint in places that previously existed brackets

and attachment points of the protection grid in the windows of the first floor, which indicates a lack of maintenance of the façade after these changes.

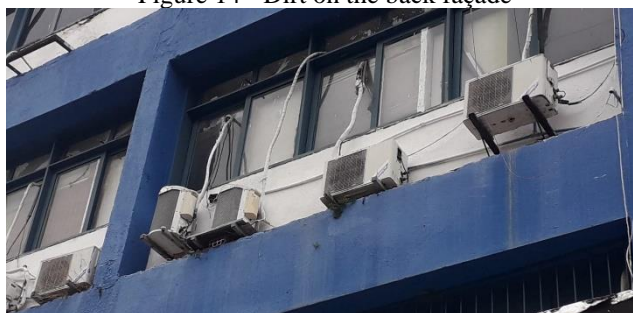
There is a recurrence of dirt (Figure 14) in the area just below the air conditioning condensers, which should happen due to the high amount of drains draining water through the façade.

Figure 14 - Dirt on the back façade

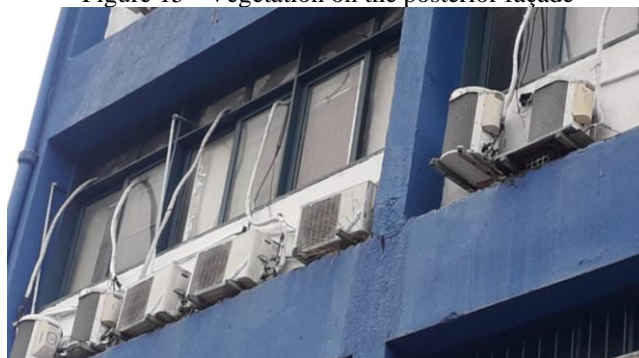
Due to the location of the posterior façade, without other buildings that make it difficult to access birds and light, it is possible to observe some points with vegetation (Figure 15) that take advantage of the humidity due to the condensers of air conditioning.

Figure 15 - Vegetation on the posterior façade

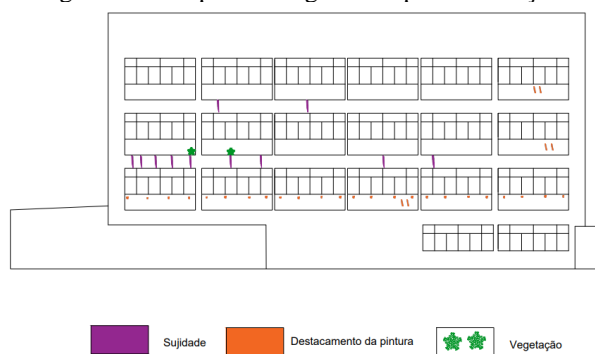
Figure 16 - Map of damage to the posterior façade

It is possible to observe the map of damage to the posterior façade (Figure 16), which presents punctual pathological manifestations without greater difficulties to correct.
