Chapter 86

Pathological manifestations in façades of historic buildings – damage map: case study of the church Santuário Nossa Senhora de Fátima

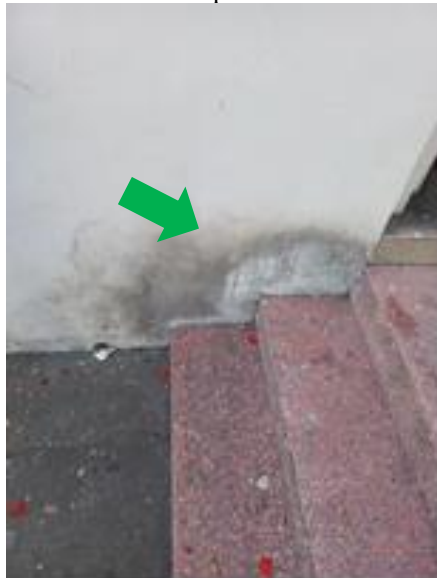
Figure 1 - Efflorescence present in the south façade.

Figure 1 shows the presence of flowering, together with dirt and moisture stains, indicating that water action is a common factor for the emergence of these pathological manifestations.

To avoid, it is necessary to pay attention to the waterproofing of wet areas to avoid continuous contact of water with free lime, and efflorescence is soluble in water. In the case of recovery, water and steel brush can be used to clean the place. Moreover, it can be applied also chemical that does not interfere in the structure. Figure 1 shows the efflorescence on the south façade.

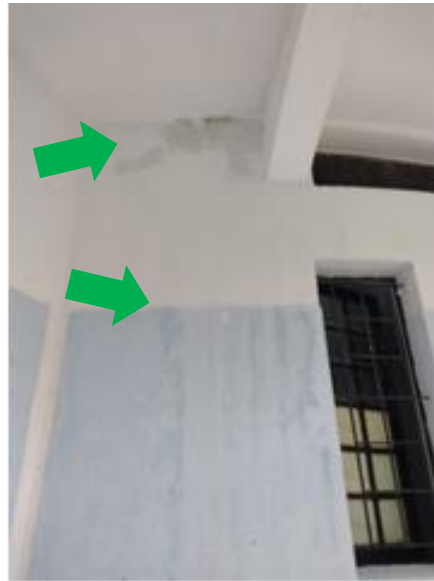
Figure 2 - Moisture stain present on the west façade.

Figure 2 shows the infiltrations present in the wall of the western façade, with moisture stains indicating the path followed by water when draining through it.

It is recommended the identification of infiltrations present in the structure, originated by maldone waterproofing, moisture in wet spaces, such as kitchens and bathrooms, water that comes from rain and affects facades, water coming from the ground, water from various leaks, porous materials used in construction, water coming from the ceiling, in poorly waterproofed slabs, among others. Recommended, after identifying and correcting the source of infiltration, perform a new waterproofing. It is noteworthy that all waterproofing has an estimated time of effectiveness and a guarantee, the estimated time can only be achieved with the proper maintenance being performed (Souza, 2008). Figure 2 shows the record of moisture stain present on the west façade.

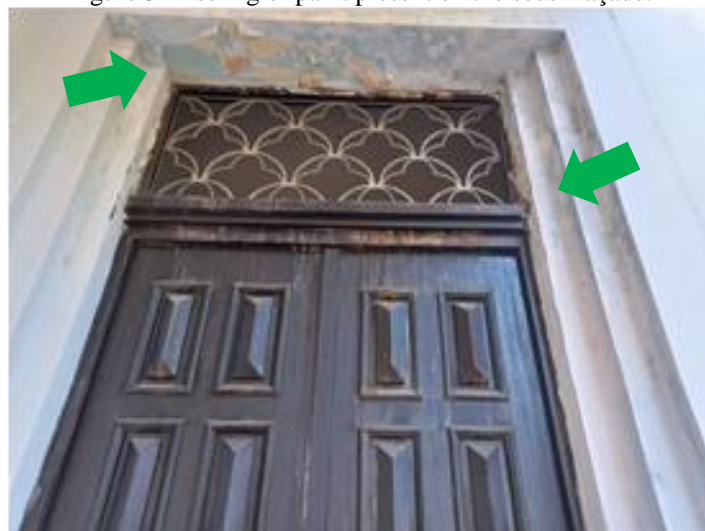
Figure 3 - Peeling of paint present on the south façade.

Several pathological manifestations are identified in Figure 3, with emphasis on the intense peeling of the paint around the door and the deterioration of the wood.

Figure 3 shows a mechanical wear process with greater intensity at the ends of the right door of the south façade, worsening by the vertical flow of rainwater over the surface of the door and the presence of sea air, which occurs because it is located in a coastal region. To reduce moisture damage it is recommended to start applying the waterproofing agent, which can be stain or varnish, with the use of brushes, brushes and rolls for wood, or even conventional paint gun; apply three coats, respecting the drying intervals indicated by the manufacturers and wait for the drying completely.

The presence of corrosion of the edges of the grids belonging to the doors of the south façade was identified, as can be seen in Figure 3, and, and according to the situation found, it is advisable to clean the material with a steel brush and products to facilitate its removal, after cleaning it is recommended to paint the part with epoxy paint or synthetic enamel for protection of the part, avoiding direct contact with water, which is essential for the oxidation process to occur.

To make the correction of the peeling of paint identified in the south façade, with it is possible to observe in Figura 3, one must follow the following steps: scrape the loose parts with a steel brush, then correct the deep imperfections with plaster dough, wait the time for its cure, apply a background hand preparer to walls, and, after drying, it is possible to reapply the coating (Schonardie, 2009; Alves, 2010; Costa & Silva, 2022).

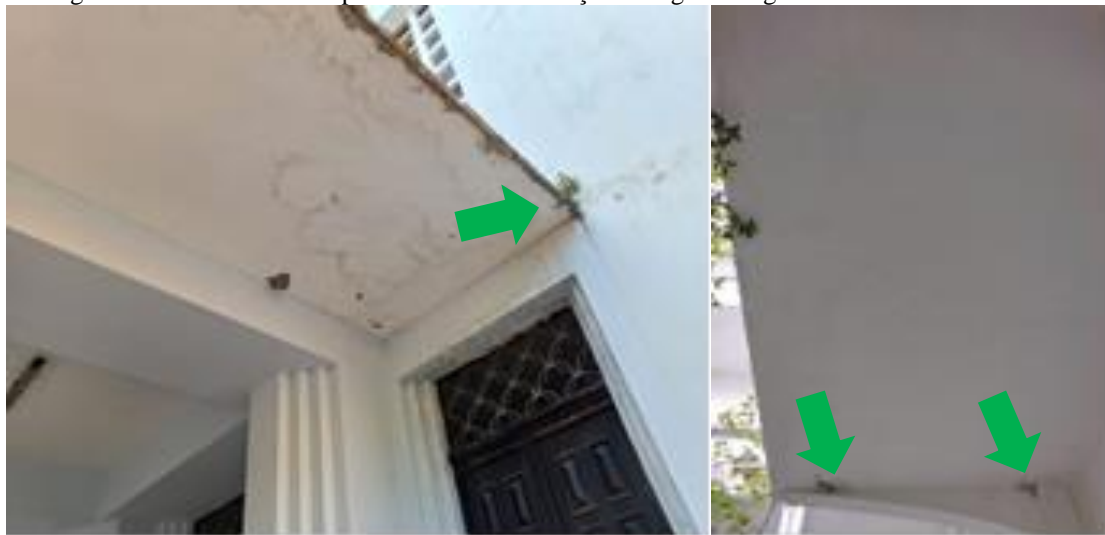
For the existence of vegetation growing in the structure, visualized in Figure 4A, there are several possible causes, such as the presence of organic matter in the sand used in the execution of the work and the transport of organic matter by animals or any other means possible, such as the existence of a tree near the building.

Vegetation in buildings, in general, indicate the presence of moisture and organic matter. In the previous topics, the presence of moisture was confirmed at certain points of the building and, with the presence of vegetation, the presence of organic material can be confirmed. Caso the organic matter has been introduced into the structure in the execution phase, there would be the presence of reactive substances throughout the structure facilitating the contact of concrete with sulfates and alkalis, being harmful to its useful life. In lack of maintenance, the areas accessible to water, eventually will be colonized by the roots, they can settle in fissures and, thus, potentiating them, compromising the structure.

Figure 4 - Biodeterioration present in the south façade. Vegetation growth B. Presence of Mold

Mold is another pathological manifestation classified as biodeterioration, such as vegetation, visualized in the structure studied, as shown in Figure 4B. The emergence of mold is interconnected with the existence of moisture, it is possible to avoid this problem through some measures, such as using hydrofugue materials in the necessary steps while they are building, opting for good solar lighting to the extent that it does not harm the well-being of individuals and also carry out a project that addresses the possibility of cross ventilation. When it comes to the exterior of the building, as there is a greater contact with humidity, it ends up facilitating the deposit of water in several places, so there has to be greater attention to these conditions and avoid them. Figure 4 B shows the appearance, still initial, of the mold in the transverse section of the slab in a balance sheet present in the north façade.

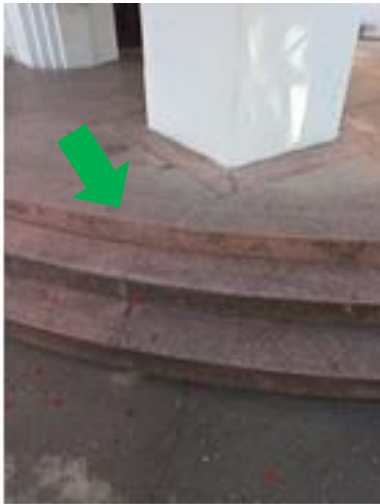
In the case in question, it observed the presence of cracks near the pillars on the south façade. The action of water and the retention of the same in the structure, reducing its resistance and consequently its useful life, the presence of vegetation nearby, in which the growth of roots of shrubs or trees are always in the direction of the largest accumulation of water nearby, entering and increasing existing cracks, and the retraction and dilation of the material exposed to climatic conditions, may be some of the causes of this pathological manifestation. To avoid cracks it is important to have the proper expansion joints where the project asks for, they are a point where tensions are softened giving a safe space for the structure to move without damaging the building. During construction, perform properly and respect the curing process of concrete and mortar (Thomaz, 2020). Moreover, in this situation of completed structure, it is important to monitor this pathological manifestation and, thus, to verify whether they are active or passive fissures (Leitão Neto, 2022). Figure 5 presents the fissures present near the pillars on the south façade.

Figure 5 – Cracks in the south façade.

A. Crack In the stairs.

with the opening filling. Contudo, in case of active fissure, it will be necessary to find out the cause of the origin of this to obtain the complete solution of the problem.

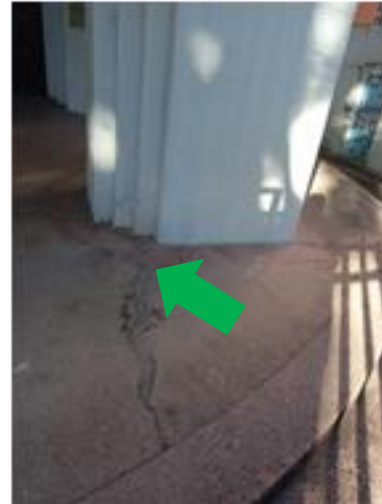
B. Crack Near the pillar

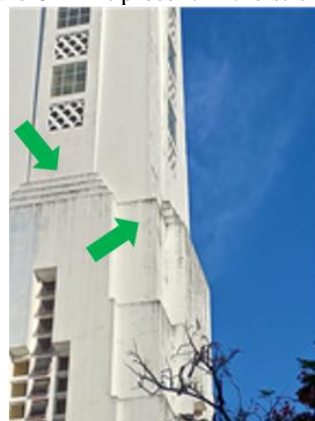
It was verified the presence of dirt in the building, possibly due to the large exposure of rainwater that when draining through the façade spread and deposit the pollution particles mainly in points of discontinuities, where these strange fragments support the force of water flow, which is slower due to the bumps and inclinations, causing accumulation in these points. This is confirmed in Figure 6, which is one of the photographic records of dirt in the Church Sanctuary Of Our Lady of Fatima. The methods that are usually taken for cleaning dirt are brushing, pressure water, mechanical cleaning, chemical cleaning and detergent compresses. Cleanliness is the first measure to resolve this pathological manifestation, but when this is not enough, the next step is recovery. That is, the scraping of the site that was cleaned followed by the application of a seamer or primer, to receive the paint (Costa & Silva, 2022).

Figure 6 - Dirt present in the structure.

It is shown in Figure 6 that the dirt coincides with the water path when draining through the façade of the building, being deposited in the discontinuities due to the decrease in the speed of water in these points.

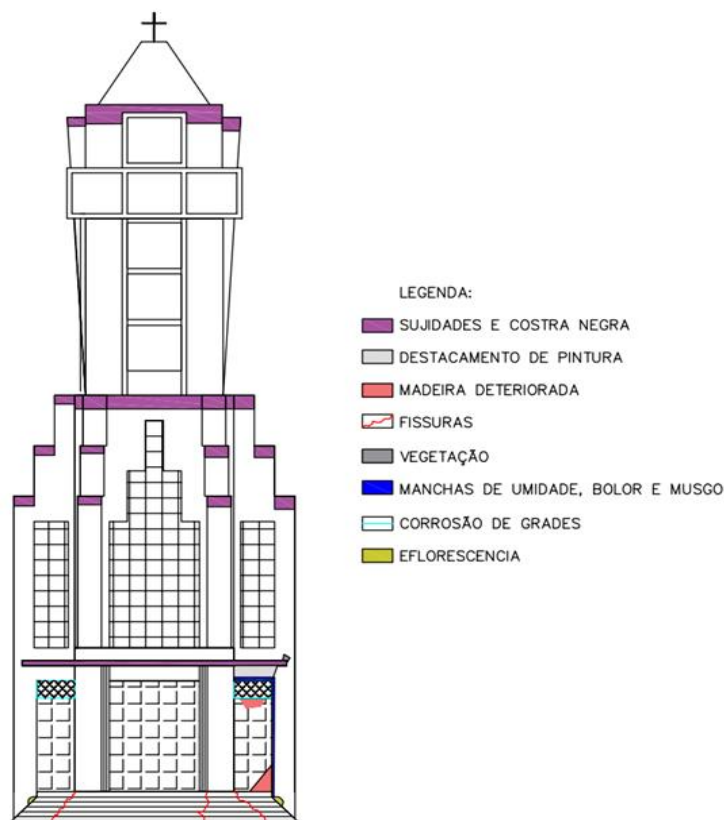
Figures 7 and 8 show the damage maps of the facades norte and sul of the church, respectively. A higher concentration of pathological manifestations is perceived in the areas with cumulative water potential, especially not the right side, the south façade of the structure, with the presence of dirt standing out in the points of discontinuities and greater difficulty of cleaning the facades mentioned. The peeling of the paint around the right door, accentuated by the runoff of rainwater, is another pathological manifestation that should be highlighted, affecting the aesthetics of the building, along with dirt.

Figure 7 - South façade damage map.

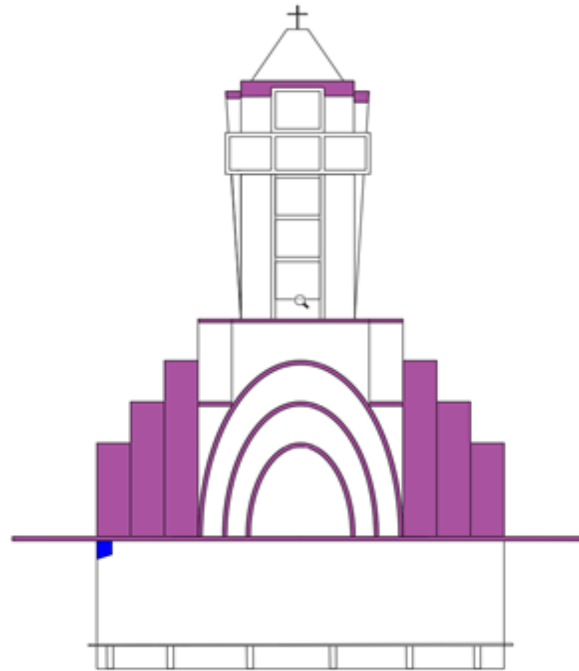
Figure 8 - Damage map of the North façade.

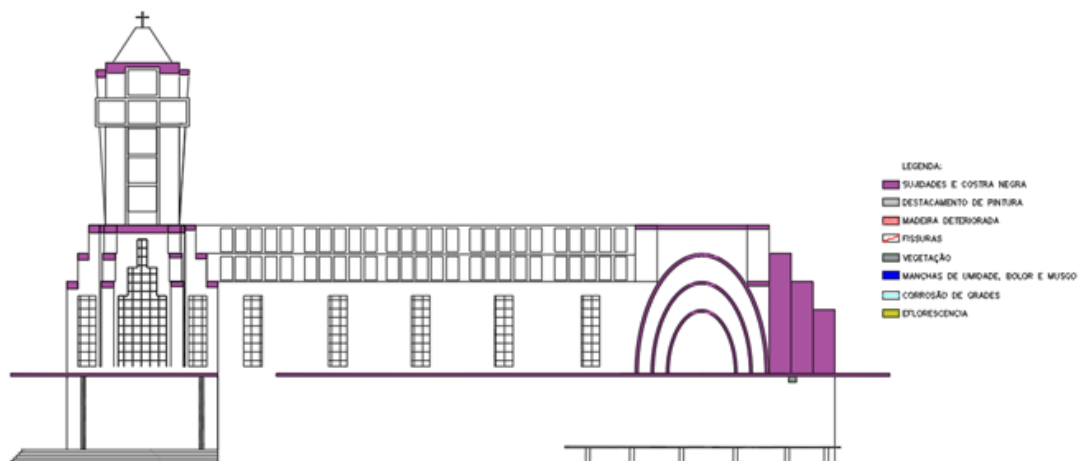
While in Figures 9 and 10A, it contains the damage maps of the east and east facades, respectively. As in the façade sul and norte, dirt is the pathological manifestation with greater concentration in the facades least and east, especially in the points of concentration of water, discontinuities and difficult to access for cleaning. In addition, it observed the presence of vegetation, favored by the moisture present, according to the map of damage of the west façade in Figure 9 and the east façade in Figure 10A. While Figure 10B presents the cross-sectional damage map of the building under study. This was elaborated with the objective of indicating, with greater precision, the presence of pathological manifestations catalogued, but that could not be visualized in the maps of damage of the facades due to their locations. Not the same, it is noticed the presence of moisture and mold stains, due to the accumulation of water in the balances of the structure in rainy season

Figure 9 - Damage map of the West façade.
