Chapter 39

Product Proposal For Restoring Residential Facades In Historical Sites Using A Lime-Based System

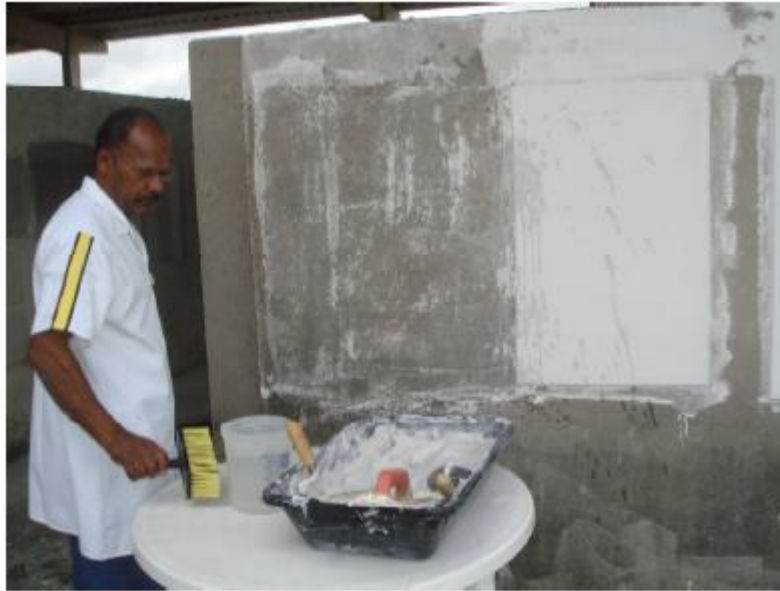
The first application was carried out on cement, lime and sand plaster with a curing time of more than 28 days. The application thickness was 20 mm, therefore in disagreement with the manufacturer's recommendations, which indicate thicknesses between 3 and 5 mm. (Figure02).

Figure 02: Base preparation for plaster application
Source: ALVES JÚNIOR, 2009.

Before application, the base was moistened to reduce the absorption of the support when in contact with the coating mortar, as shown in figure 02. The application was carried out using a PVC trowel and a trowel. (Figure 03)

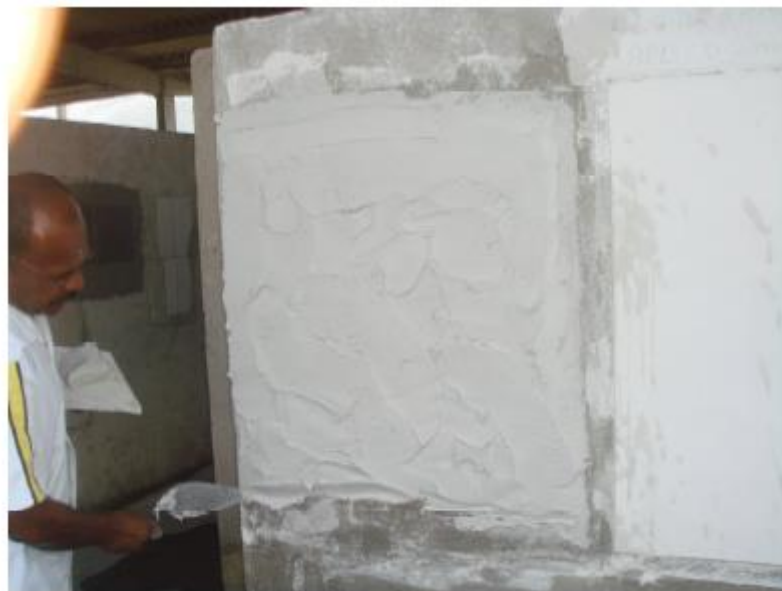
Figure 03: Application of lime mortar on cementitious substrate
Source: ALVES JÚNIOR, 2009.

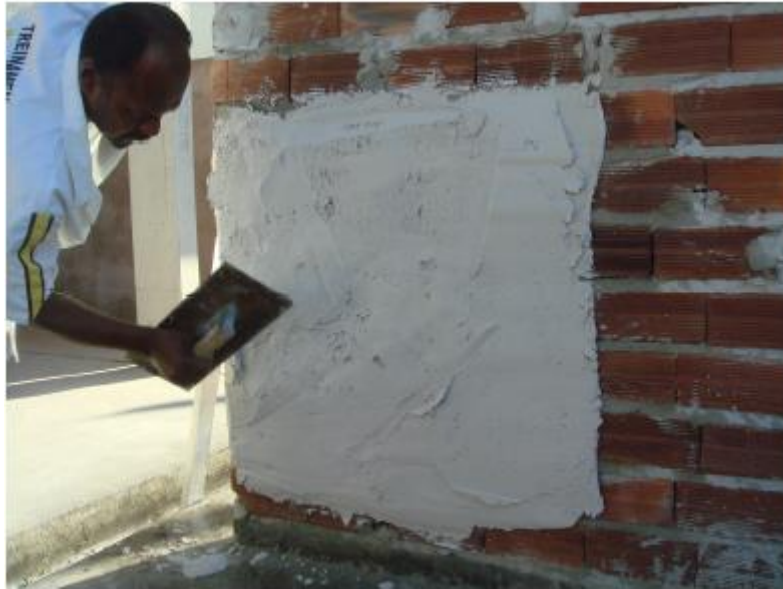
The entire coating operation was also carried out on a masonry surface, without base preparation, only cleaning and wetting the substrate as per (figure 06).

Figure 06: Direct coating application on the masonry
Source: ALVES JÚNIOR, 2009.

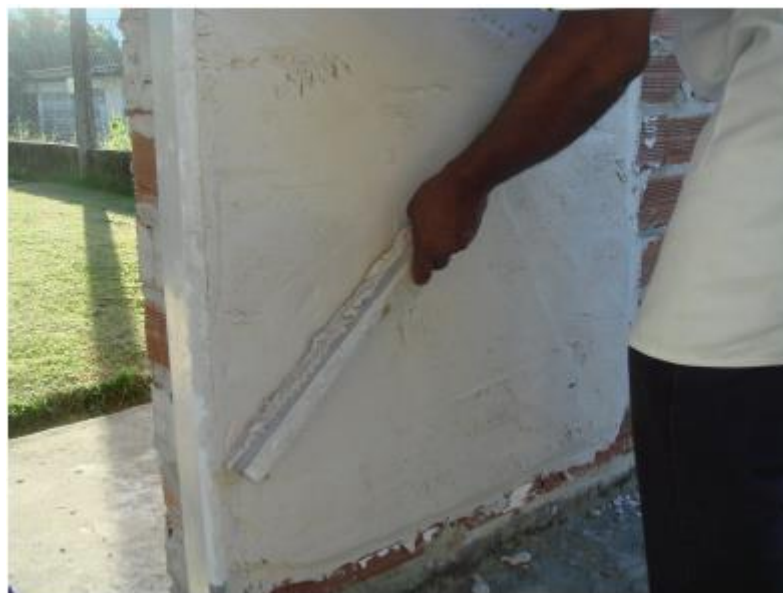
In the application, there were no significant changes in the product due to the difference in the substrate. After a period of “pulling” the mortar, the surface was evened out using slatting, using an aluminum ruler (figure 07).

Figure 08: Mortar mortar applied directly on the masonry

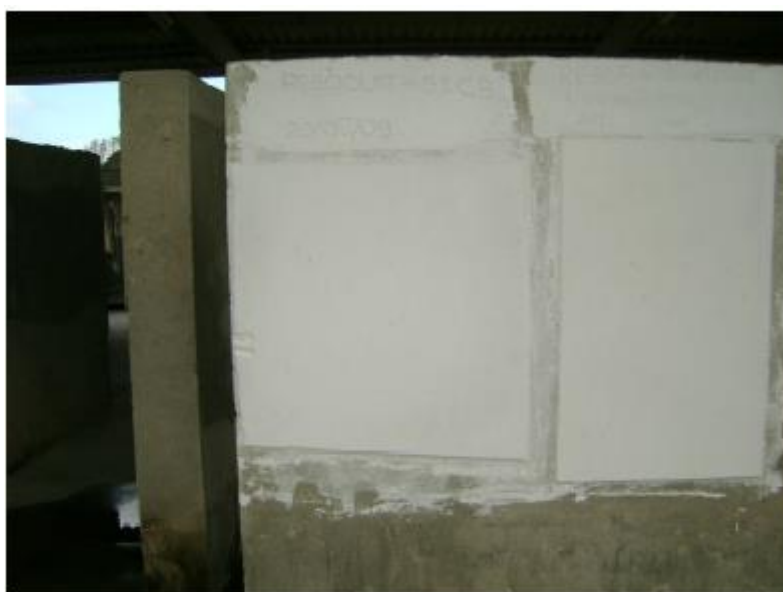
Figure 10: Coating executed with industrialized mortar with addition of CPB-40

After 24 hours of application, no surface changes were observed in the coating layer applied on a cementitious substrate. Small cracks were found, possibly due to the thickness of the coating, outside the standards recommended by the manufacturer.

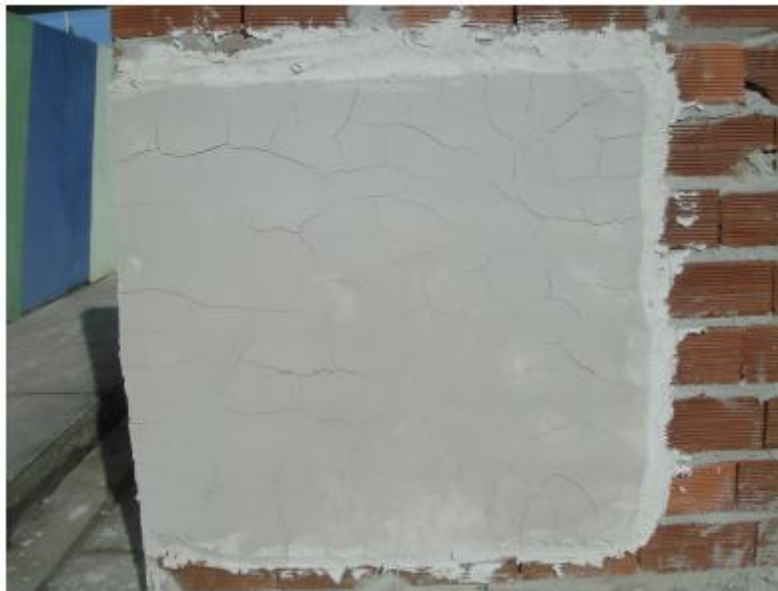
In the coating applied over direct masonry, however, mapped cracks were formed, indicating a direct relationship with the absorption of the base (figure 11). In addition to this aspect, the finish with excessive flatness and the excess of fines, caused by the addition of cement, in addition to the thickness used, outside the manufacturer's recommendations, can explain the pathologies verified in the coating.

Figure 11: Formation of cracks mapped in direct application on masonry
Source: ALVES JÚNIOR, 2009.

Another important aspect in the application is related to the moistening of the foundation. Ceramic brick masonry in general has high absorption and, if not well moistened, causes mapped cracks on the coating surfaces. In fact, before applying each layer, and especially the first one, the substrate was pre-wetted. Such reactions could be observed in tests carried out both under controlled laboratory conditions and in applications on external walls without humidity and temperature control. Pre-wetting also favors greater control of the temperature of the base to be coated, avoiding the sudden escape of the mixing water, either by suction from the base, or even by evaporation.

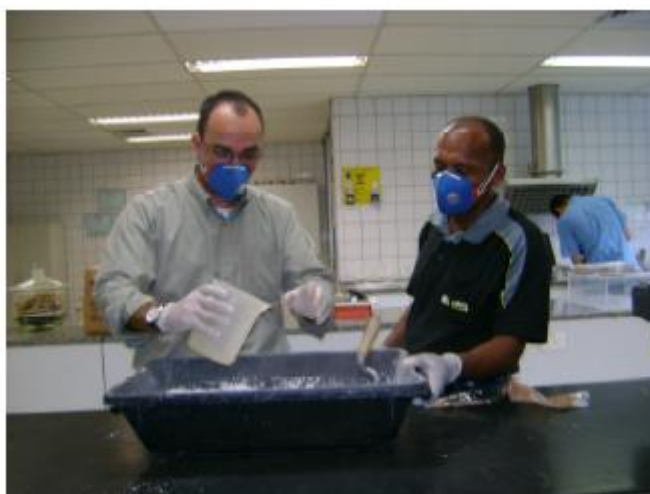
For the application of the product, a masonry wall of ceramic bricks was used, with 8 holes, (9x19x19 cm) settled with industrialized mortar, joints of 20 mm. Before applying the first layer (base preparation), the substrate was cleaned and previously moistened. The product was prepared in an airtight container, mixed by hand until obtaining a homogeneous mass without lumps. The mixture was carried out using a liquid additive mixed with the mixing water (1:4), whose objective is a better performance of the coating in relation to adherence to the substrate. (Figure 12).

Figure 12: Preparing mortar A2

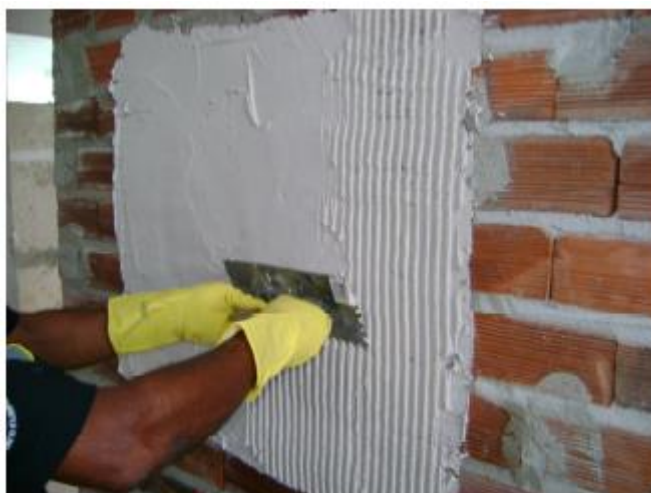
After 24 hours of application of the base layer, with a thickness of 5 mm, the application of the plaster body or intermediate layer was started, which had a thickness determined at 10 mm, in order to avoid cracks caused by large thicknesses of the applied coating in a single layer. (Figure 13).

Figure 13: Execution of base preparation
Source: ALVES JÚNIOR, 2009.

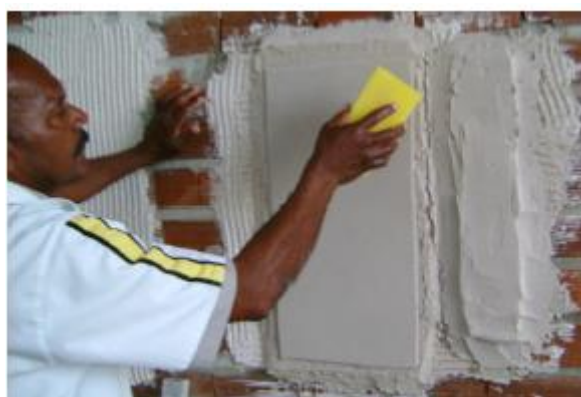
After 24 hours of execution of the plaster body, a finishing layer or smoothing with a thickness of 5 mm was applied. The finish was carried out by smoothing the surface, using a plastic trowel and then using a slightly damp sponge in circular motions. (Figure 14).

Figure 14: Smoothing with sponge

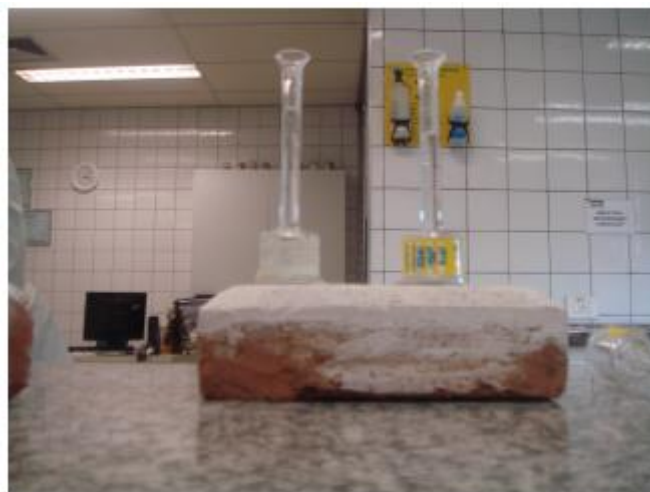
The test was carried out based on NBR 14992:2003, in strict compliance with Annex G of this technical standard for determining the permeability of a hardened specimen when subjected to a water column of 13 cm.

The product did not withstand water pressure, showing an absorption equivalent to 4cm³ for a 13 cm high water column for 8 minutes. Thus, we can say that the product offers good conditions for the coating to develop its characteristic water cycle, making it impossible to retain moisture in the masonry.

Figure 16: NBR 14992:2003 permeability test

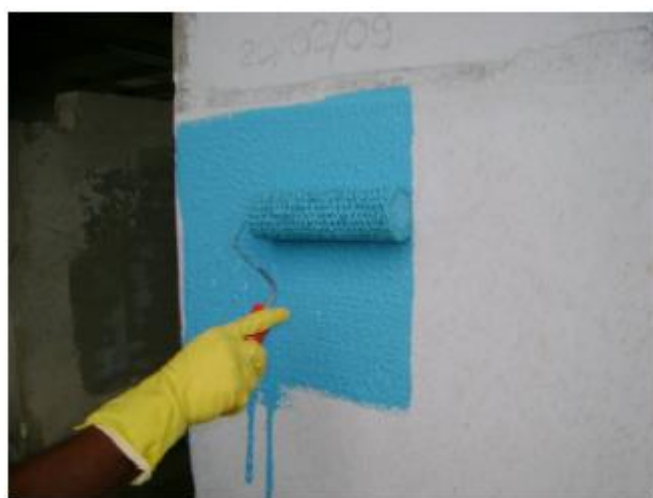
For the preservation of the urban landscape of the city, however, it would be desirable to promote the physical survey of the surface of the facades, which could identify the superimposed colors and, if desired, define the colors of the first layers of paint. With this, linguistic errors, obliteration of decorative details and other mistakes could be avoided. Therefore, lime-based paints appear to be the most reasonable solution for use on SHO facades. Firstly, because of its compatibility with traditional renders. Secondly, due to its low acquisition and application cost, allowing for more frequent maintenance. Thirdly, it allows the wall to “breathe” while still having great resistance to the formation of fungi due to its high alkalinity.

Figure 17: Execution of lime-based painting
Source: ALVES JÚNIOR, 2009.

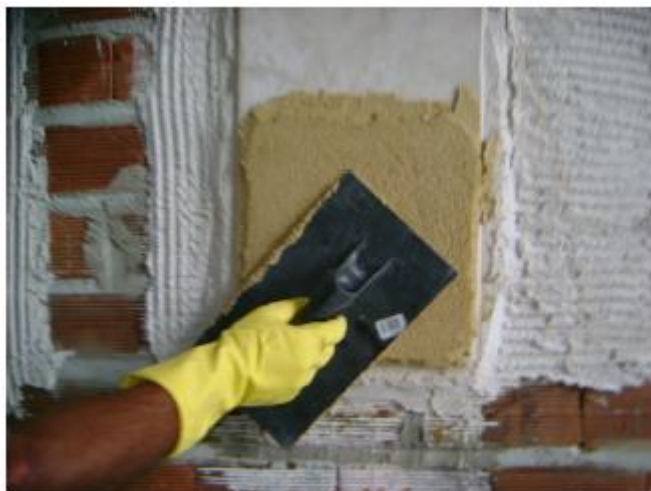
According to tests carried out in this research (A2), the final plaster layer was established with a thickness of 5 mm. This layer, if added with mineral pigments, can become a colored spreader, with high durability with the solutions currently adopted due to its thickness, compatibility with the substrate, and constitution. (Figures 17, 18, and 19).

Figure 18: Finishing with a trowel
Source: ALVES JÚNIOR, 2009.

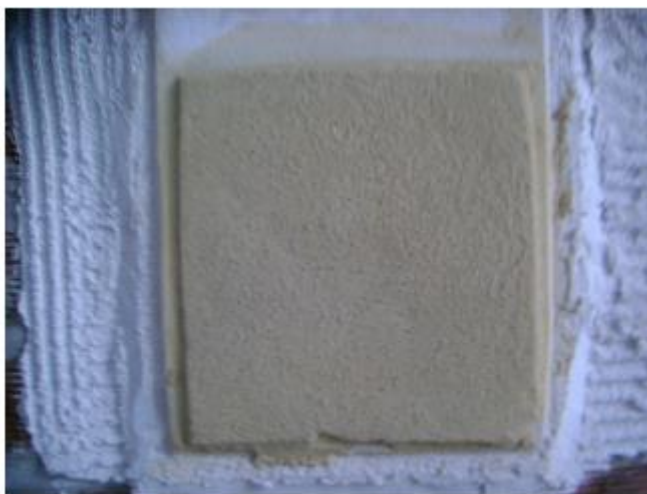
Figure 19: Final coating texture detail
Source: ALVES JÚNIOR, 2009.
