Study of surface treatment techniques for industrial painting in near shore environments

ABSTRACT

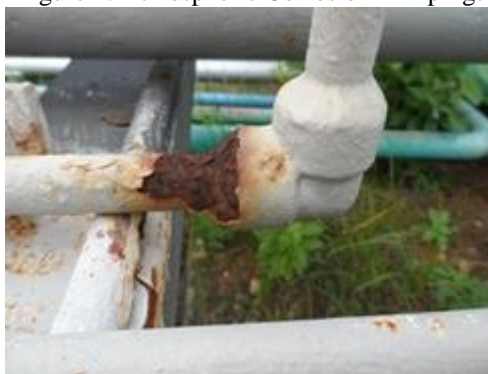
Figure 1: Atmospheric Corrosion in Piping.

For Jambo and Fófano [7] atmospheric corrosion is defined as an electrochemical process that occurs in local batteries, thus requiring the presence of an electrolyte. Such electrolyte is formed by the condensation of water on the metallic surface and this water film will depend, mainly, on the relative humidity of the air. Figure 1 shows an example of atmospheric corrosion in an industrial environment located on the shores of a seafront:

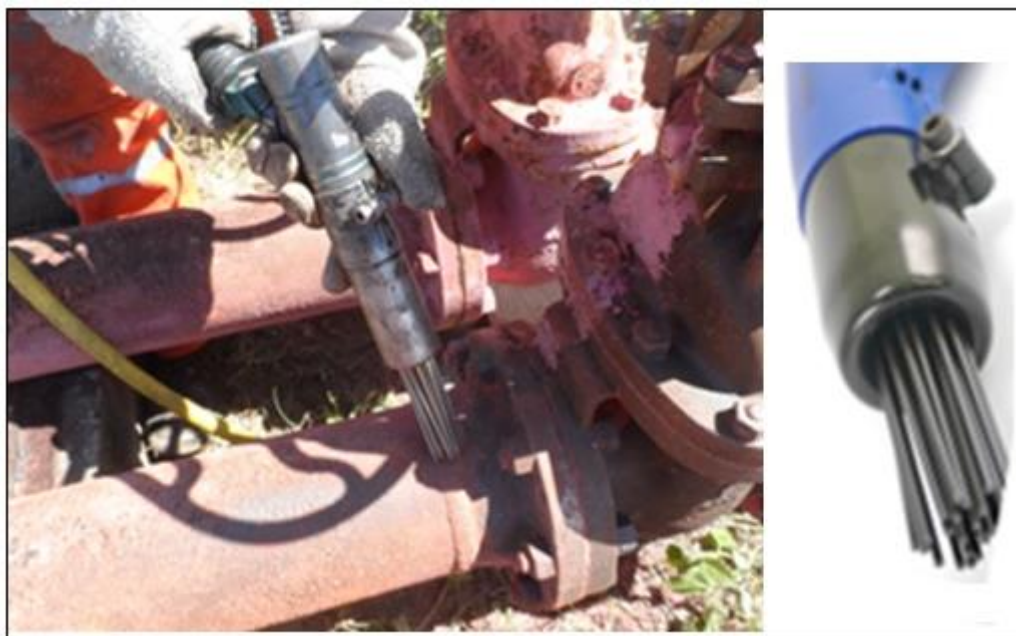
Figure 2. Action of the needle gun in the preparation of the metallic surface.

making contact with the contaminated surface [18]. The vibration of the rods or needles, usually made of steel or beryllium, in contact with the surface, provides the removal of paints and surface oxides in order to generate the necessary finishing degree for the painting to be applied, as shown in figure 2.

Stango et al. [18] state that during the contact of the needles with the substrate, that is, when the bundle of rods parallel to the surface of the workpiece is attrition, there will be a rapid oscillation in the axial direction of the tool, providing a repeated movement between the tips. of the rods and the target surface. This frequent contact allows the removal of surface debris and simultaneously generates the desired surface texture.

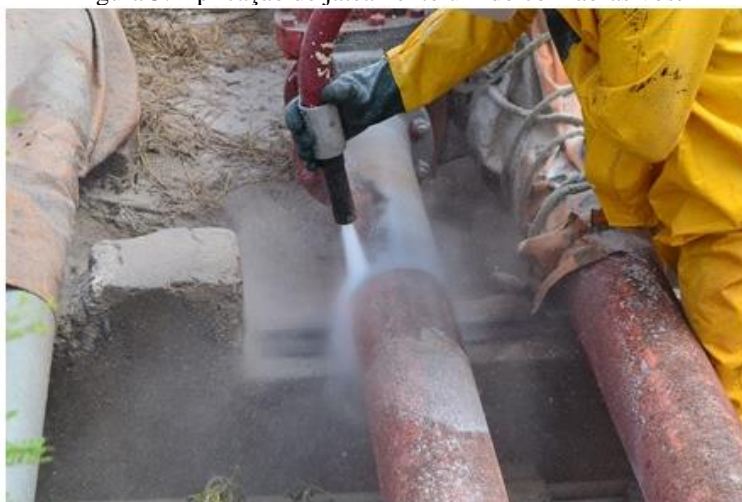
Figura 3: Aplicação de jateamento úmido com abrasivos.

In industrial environments, two types of blasting are normally used during services: dry abrasive blasting and wet abrasive blasting. The latter, in addition to using compressed air and abrasives, blows using water in the mixture that will be propelled onto the work surface. An example of wet blasting used in this research is shown in figure 3.

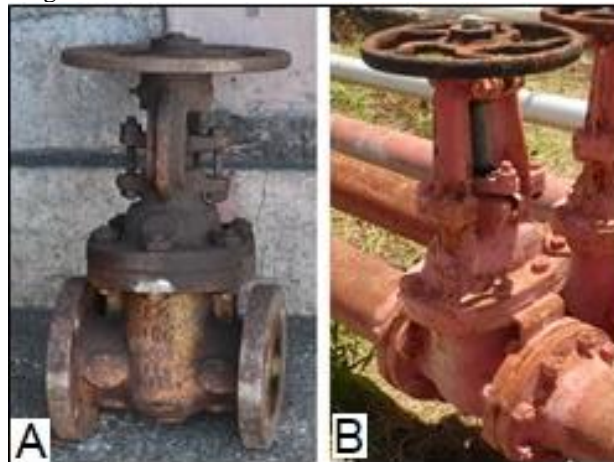
Figure 4: Valves available for in-cab and field treatment.

Initially, two valves were separated to be worked on in a surface treatment cabin environment, seeking controlled working conditions, similar to a real situation of services in a blasting cabin carried out at a construction site. At the same time, a valve that belonged to a section of piping assembled in an industrial area was also chosen, so that it represented the real conditions of an activity carried out in the field. Figure 4 addresses the valves in the two study conditions before treatment.

The valve that received the surface treatment in the field was mounted and operated for more than ten years in a fire network piping. This section of pipe was chosen because it is located in an open area, at ground level and easily accessible for carrying out and monitoring the experiment.

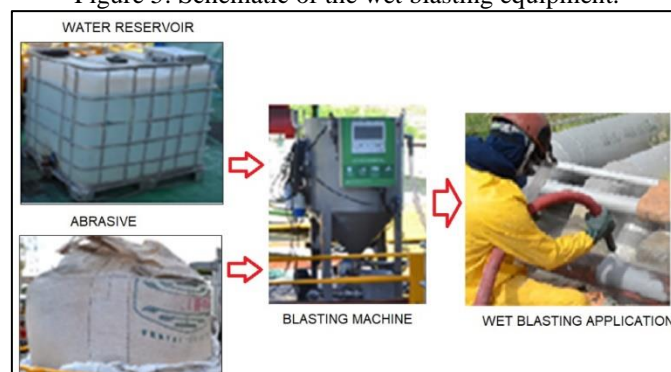
Figure 5: Schematic of the wet blasting equipment.

It is important to point out that the wet abrasive blasting machine was initially configured in the blasting function, where effective treatment of the surface of the valves was allowed. Following the treatment, the surface was washed to remove oxides and loose paints resulting from the treatment and finally the surface was dried with dry air.

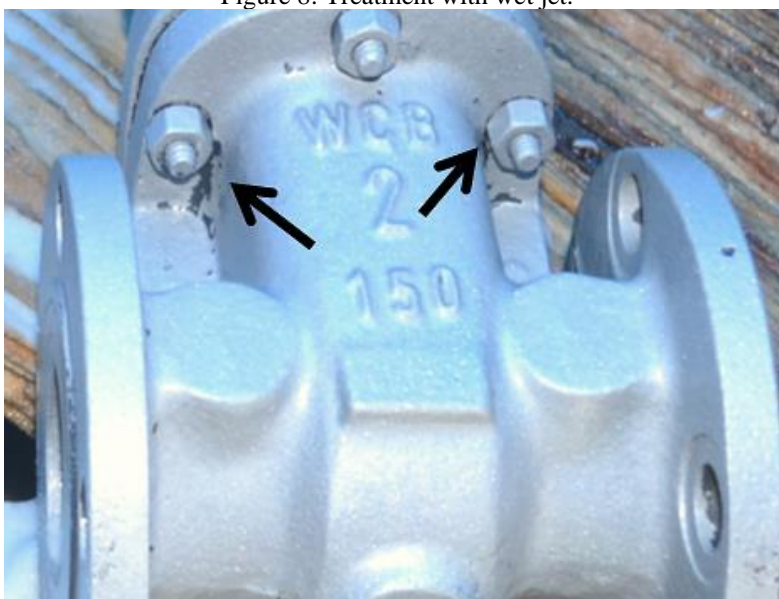
Figure 8: Treatment with wet jet.

The appearance of the surface treated with wet abrasive blasting visually showed an apparent quality superior to the mechanical treatment that was carried out with a needle gun, as shown in Figure 8. Cleaning characteristics were observed in which the steel had a lighter color than the metal, tending to gray-white when compared to the surface treated with a spray gun. However, dark deposits that were not completely removed are also noted, although no ink deposits were observed.

Another aspect identified was the absence of virtually no trace of remaining ink. The wet blasting, when compared to the treatment with a needle gun, showed a surface where there were no spots of adhered paint not removed from the surface, in addition to corrosion products or any other foreign matter that could be present on the surface at the moment before the treatment.

In view of the verified characteristics, it can be seen that the surface treated with wet abrasive blasting is classified as CSa3 based on the ISO 8501:1[24] standard, which characterizes the white metal blast cleaning classification.

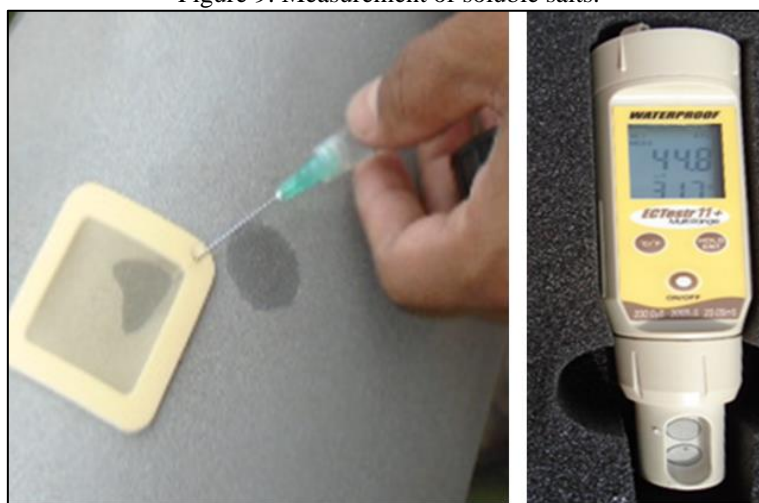
Figure 9: Measurement of soluble salts.

The measurement was initially performed with the fixation of the adhesive on the surface that received the treatment. Using a syringe, distilled water was introduced into the area delimited by the adhesive. After waiting for one minute, the water was removed and inserted into the equipment, which recorded the amount of salts present on its display. Figure 9 records the photographs of the moments of distilled water collection and measurements recorded on the equipment display.

The value found in the measurement performed on surfaces treated with a needle gun was 4.67 $\mu\text{g}/\text{cm}^2$. In the measurement performed on the surface that received abrasive blasting, the value was 4.48 $\mu\text{g}/\text{cm}^2$. These values measured within the measurement range of the equipment represent the amount of impurities (salts) found in each technique for comparison between them. This difference is not representative considering concentrations of the order $\mu\text{g}/\text{cm}^2$. The Petrobras N-9 standard [22] cites the concentration of soluble salts in water at a maximum value of 5 $\mu\text{g}/\text{cm}^2$ as acceptable for use in wet blasting. Thus, the results found are not significant for the evolution of the corrosive process.
