Identification of pathologies and maintenance techniques in a semi-buried reservoir

João Victor Pereira Jizuato

Ana Paula Moreno Trigo Gregui

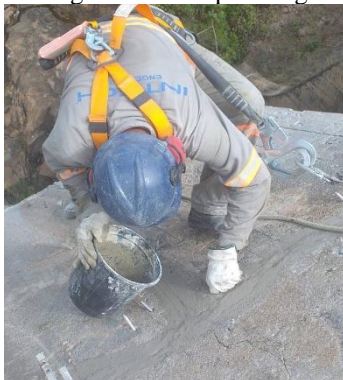
Figure 3: Main pathologies in semi-buried reservoirs and materials applied for their recovery

Cracks – sealing with grout.
Source: *Intech Engenharia* (2016)

Sealing is a technique used in cracks greater than 10mm and aims to seal the crack using adherent material, with chemical and mechanical resistance, such as *grout* and in some cases epoxy (SOUZA AND RIPPER, 1998).

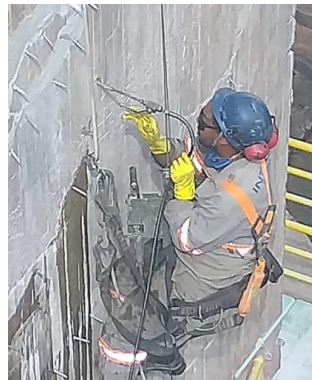
Cracks – injection of polyurethane. Source: *Intech Engenharia* (2016)

To close cracks, the injection process with hydroexpansive polyurethane is used to solve water leakage problems. The injection technique is widely used to end water infiltrations. When the hydroexpansive polyurethane comes into contact with water or moisture, it promotes an almost instantaneous expansion relationship, forming a solid foam barrier with closed cells, filling and waterproofing cracks, cracks and pores through which water has access (MONGE, 2002).

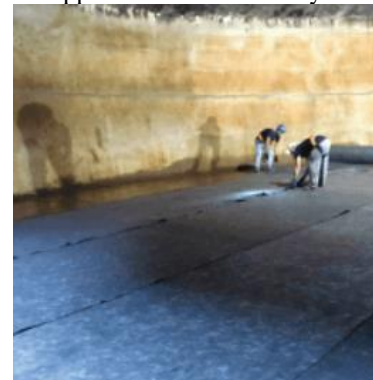
Waterproofing – application of blanket. Source: *Tae Magazine* (2020)

With the deterioration of the waterproofing of asphalt blanket, causing loss of functionality, it is necessary to perform all the removal of the waterproofing, by scraping process with brushes with steel bristles and hydro blasting, in order to ensure a more adherent surface, eliminating any type of elements that impair the interaction with the new waterproofing of asphalt blanket (CRISTINA, 2020).

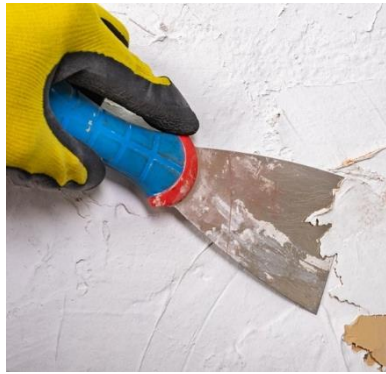
Paint deterioration – scraping.
Source: Revprol (2022)

There are several causes that generate pathologies in paintings, so they have several intervention alternatives, the most recommended being to completely remove the damaged paint and apply a new layer (ZUCHETTI, 2015).

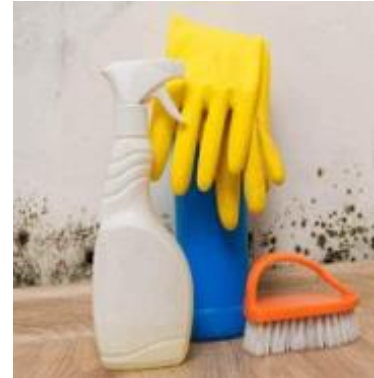
Mold and mold – mold/mildew cleaning.
Source: Tricurious (2018)

The removal method is a cleaning service that consists of washing the affected areas, with a nylon brush and with a high pressure washer, and after drying, must pass a waterproofing for the protection of the same (FONSECA; ROCK, 2021).

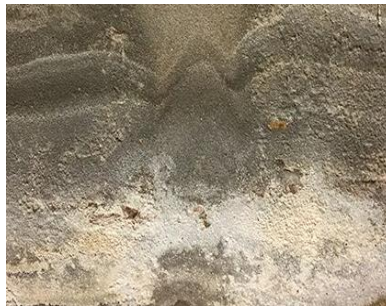
Efflorescence.
Source: Aecweb (2023)

It is possible to remove the saline deposits by cleaning with acetic acid, however, depending on the level of degradation, it may be necessary to recompose the structure. According to AecWeb (2023), the most adopted solution to resolve efflorescences is the use of waterproofing materials on substrates with lime-free coating mortar.

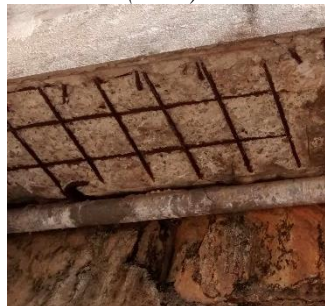
Corrosion in the armor
Source: Silva (2018)

For the recovery of corroded structures in reservoirs, it is suggested to measure the affected steel area. If it does not exceed 15%, the treatment will be done without the need for adding bars, performing the repair as Piancastelli (1997) recommends:

- a) remove all disaggregated concrete;
- b) clean the reinforcement by removing all corrosion products with suitable brushes;
- c) apply corrosion inhibiting polymers on the bar;
- d) perform the repair according to the depth affected.

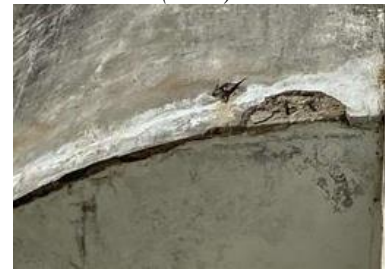
Concrete deplating
Source: Batista (2022)

For the recovery of structures that are with concrete deplating, Piancastelli (1997) recommends the use of grout, following the reconstruction procedure:

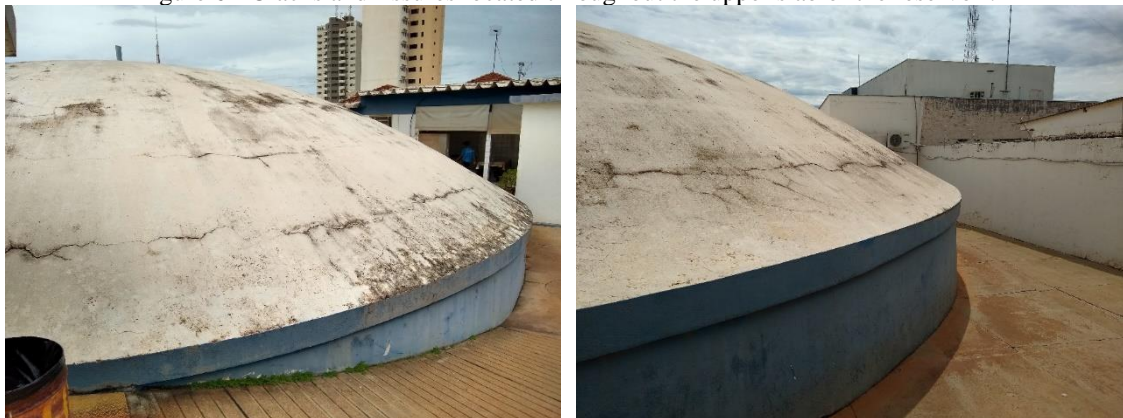
After external inspection of the area, a series of pathologies present in the reservoir were identified, such as cracks and cracks, paint deterioration, mold and mold stains and soil repression. Figures 6, 7 and 8 show the pathologies identified.

Figure 6 - Cracks and fissures located throughout the upper slab of the reservoir.

The repair of the cracked regions should be performed by injection of polyurethane resin with the aid of injection pumps. This method presents good penetration for sealing cracks and cracks, recovering the monolithicity of the structure.

The repair of the cracks, because they have larger openings than the cracks, should be done by sealing, applying the *grout* in order to close them.

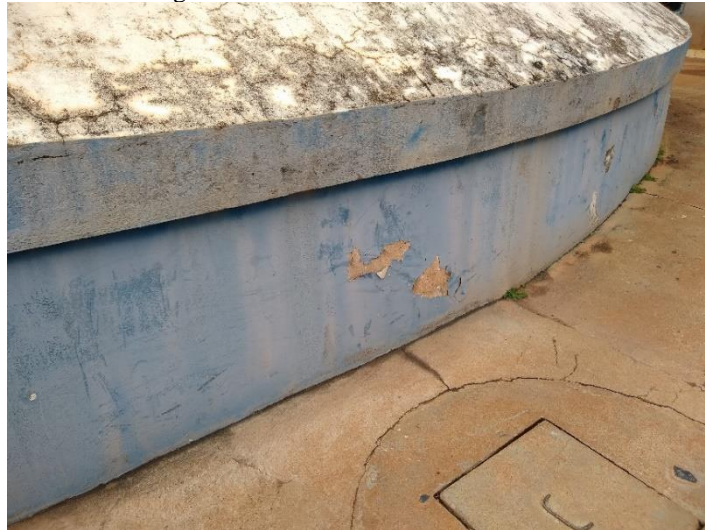
Figure 7 – Paint wear and deterioration

In places where the painting has suffered wear and deterioration due to constant contact with water and due to exposure to the elements, cleaning and removal services of the damaged surface can be performed through a scraping and washing process with a steel brush, and then the painting with the use of waterproofing paints, able to withstand that exposure effectively.

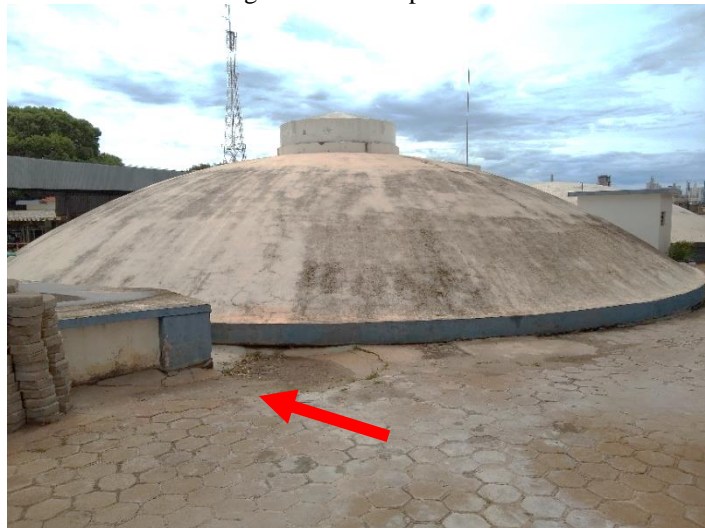
Figure 8 – Soil repression

Analyzing Figure 8, and considering the complaint of the residents regarding the presence of land in the water, it can be inferred that the repression would be responsible for a possible infiltration located in the wall of the reservoir or well, which would justify the passage and entry of land into the reservoir, thus contaminating the water.

As previously mentioned, the presence of earth in the water was a consequence of infiltration, through cracks in the wall of the suction well, caused by soil repression.

The first step is to correct this repression, effecting the regularization of the soil. Thus, the saturated soil must be removed and then carried out a landfill using the method of compaction with new soil.

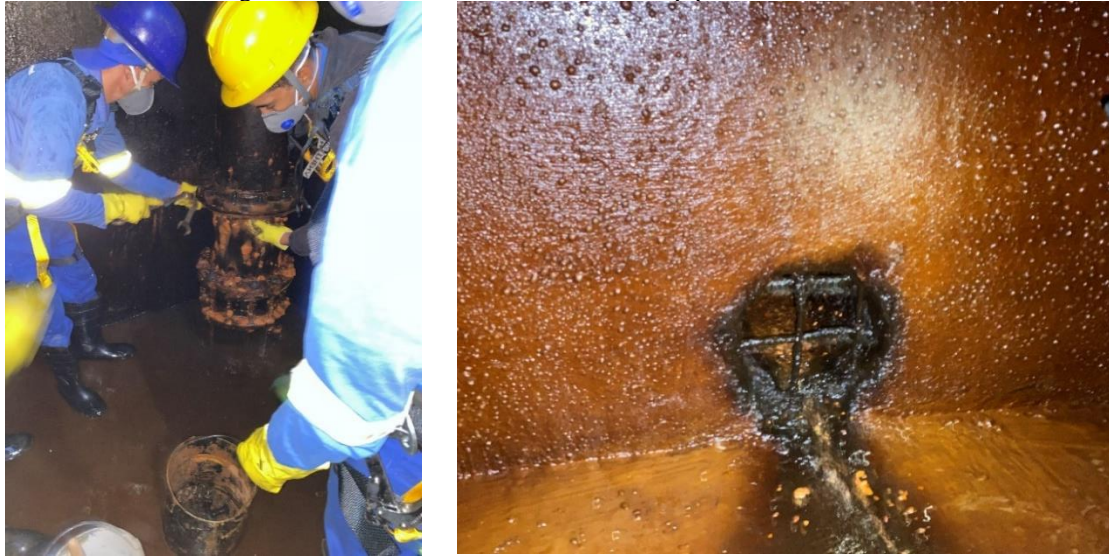
Figure 9 shows the presence of rust and corrosion in the metal pipes. Figure 10 shows the mold and mold stains inside the reservoir and Figure 11 shows the deterioration in waterproofing.

Figure 9 – Rust and corrosion in the metal pipes of the reservoir

The interconnecting pipe between the semi-buried reservoirs showed pathological manifestations of rust and partial corrosion.

Thus, one should proceed with the cleaning service, using steel brushes or sandpaper and painting with appropriate paints for the reuse of metal elements. This service is performed through sanding to remove all the rust present and, in sequence, made the painting with appropriate methods,

such as galvanized fire painting, which consists of dipping the element in a molten zinc bath at a high temperature, offering a resistant and long-lasting protection.

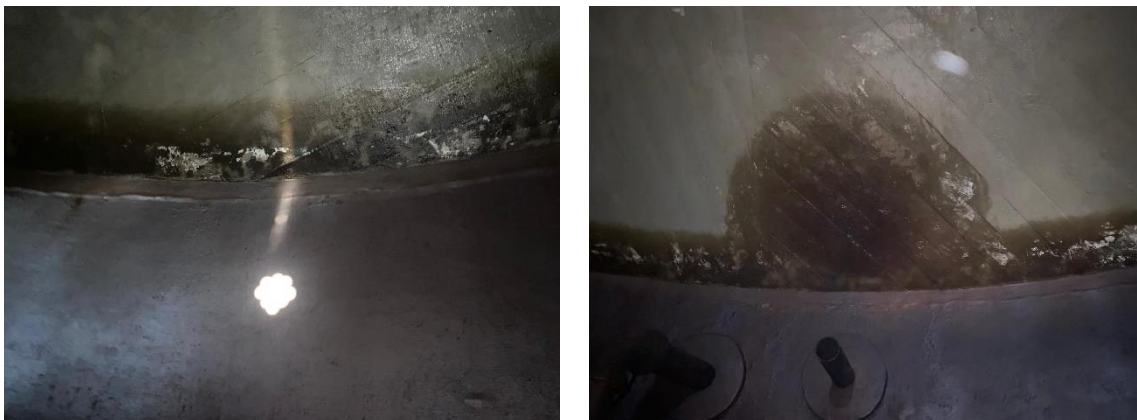
Figure 10 – Mold and mildew stains inside the reservoir, revealing water accumulation in the vault of the image on the right

For the solution of stains and molds manifested in the internal region of the reservoir, it is suggested to perform the cleaning service, proceeding to the washing with nylon brush and with high pressure washer. After drying, a waterproofing agent should be passed for the protection of the repaired areas.

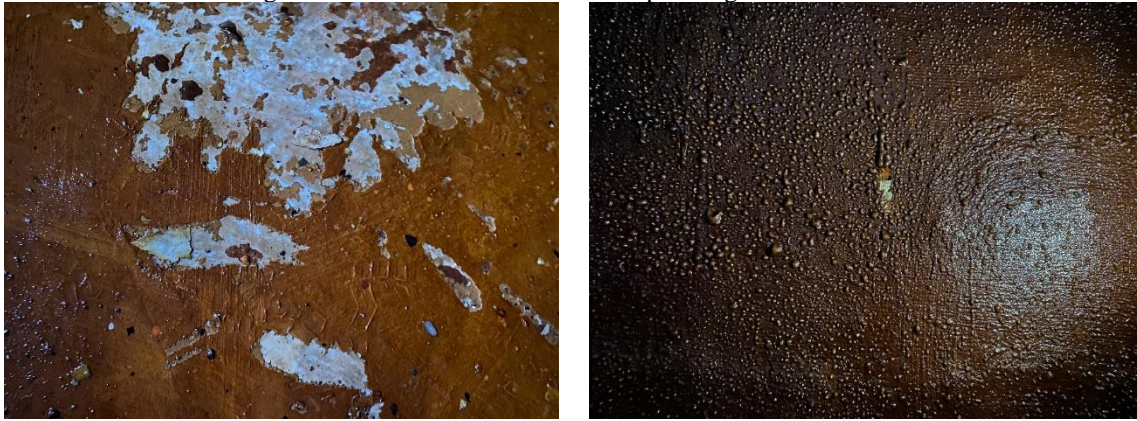
Figure 11 – Deterioration in the waterproofing of the reservoir

In addition to the pathologies mentioned, it was observed that the waterproofing of the semi-buried reservoir was in a deteriorated state, due to the end of the useful life of the product. Thus, it will be necessary to remove the existing asphalt blanket and then apply a new asphalt blanket waterproofing.
