Reinforcement evaluation with external pretension of Marcelino Machado bridge, highway BR-135, São Luís – MA

Keywords: Road bridges, External pretension, Structural recovery.

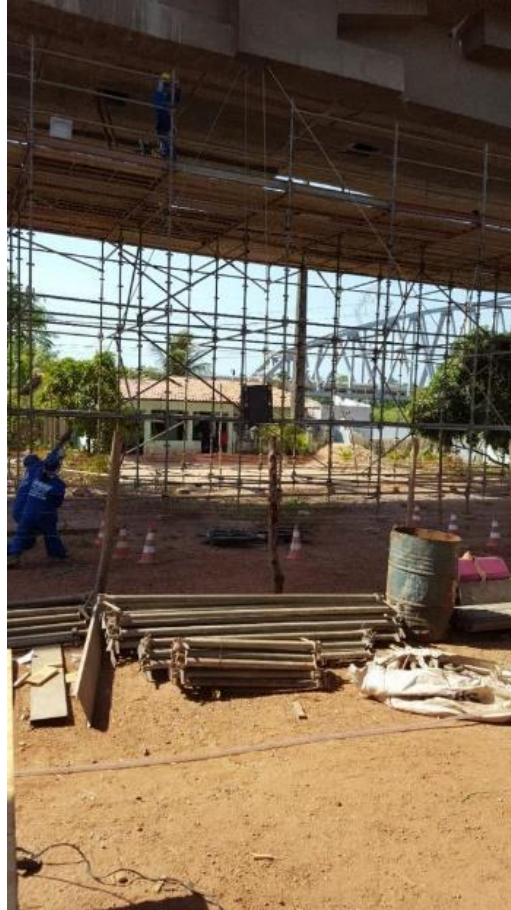
Image 1 - Scaffolding for operation of the works.

Thus, for the recovery service, the scaffolding under the bridge was installed, as shown in Image 1, for the locomotion of the workers as well as the performance of the services.

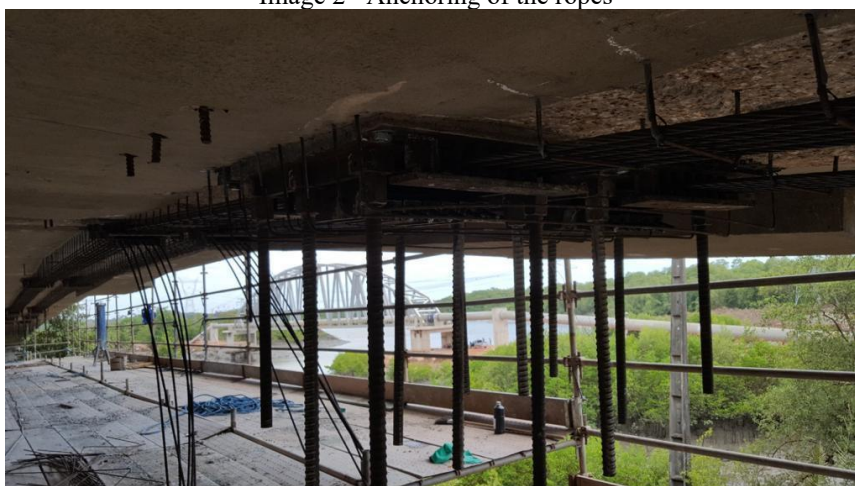
Image 2 - Anchoring of the ropes

Given this, it is worth mentioning that the process of fixing the metal devices with hydraulic pump equipment for anchoring and deviations of the reinforcement ropes was carried out, soon after the reinforcement blocks internal to the coffin beam were executed in the anchoring lines, positioning the ropes and applying the loads of pretension made by a hydraulic jack, performing the wrapping services of bundles of ropes and metal devices Image 2.

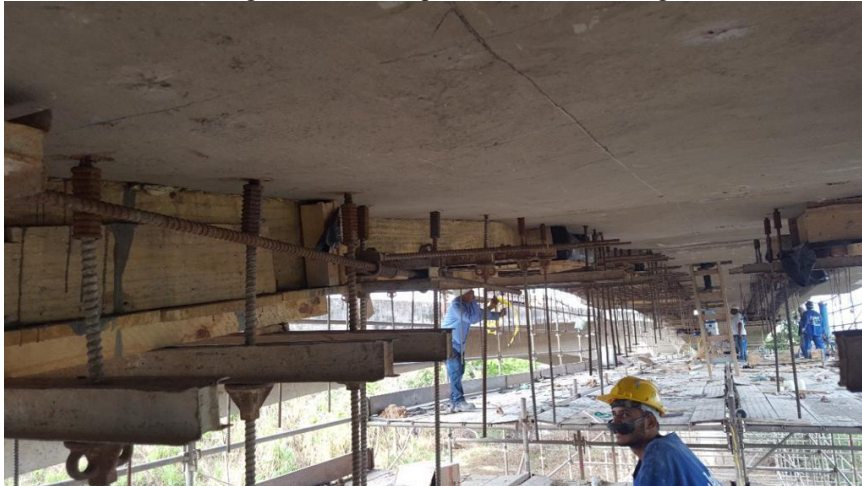
Image 3 - Of the shapes with the concreting

The concrete used was with $f_{ck} > 35$ MPa with factor ≥ 0.50 ara reinforcements internal to the coffin beam, as well as self-leveling grout mortar with the addition of 30% of pebbles for wrapping of bundles of ropes and metal devices, in this way, forms were placed and soon after the concreting as shown in image 3 below.

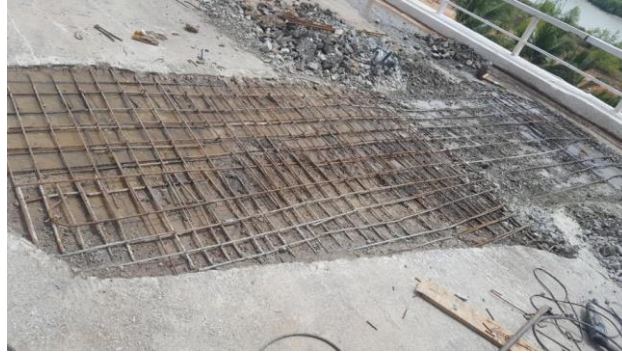
Image 5 - Cutting anchoring system

According to Litaiff et al. (2022), the method of pavement restoration should start from an engineering project, this should consist of the removal of a part or all of the thickness of the pavement, and may eventually reach the subbed, being fully implemented the new structural layer, its nature, composition and specifications must correspond to the corresponding properties of the area adjacent to the rest of the floors, as depicted in image 5.

Above all, it is of fundamental importance to expose the armor in the damaged place, leaving it exposed to facilitate access behind them, as shown in the image above. For recovery of anomalies some basic requirements must be used, with regard to the products used, such as adhesion, compensated retraction, low permeability, compatible modulus of elasticity, mechanical resistance and resistance to aggressiveness to chemical and environmental attacks, and to finish, it is essential to enable its complete cure.
