The discovery of the decline of the manhole bath in the municipality of Açailândia/MA in an environmental education project

This work aimed to show an initiative by students from the Civil Engineering Course in the municipality of Açailândia/MA to carry out an Environmental Education project aimed at raising awareness among the local population about the use of environmental septic tanks and grease traps, in an attempt to reduce the release of domestic sewage into streams close to the region, more specifically the Açailândia River. In addition to this environmental problem, this article sought to analyze the effects of water flow in the vicinity of the “banho da Bueira”, which caused land to move downhill, consequently generating siltation in this resort that was so popular and used by the population of this municipality for fun, fishing, washing dishes and clothes. In this sense, this work brings a reflection on the effects of disorderly occupation in riverside regions that should be protected by the municipal government, and that when due attention is not given, an exorbitant increase in garbage and sewage, generally produced in peripheral regions and which are carried by rainwa

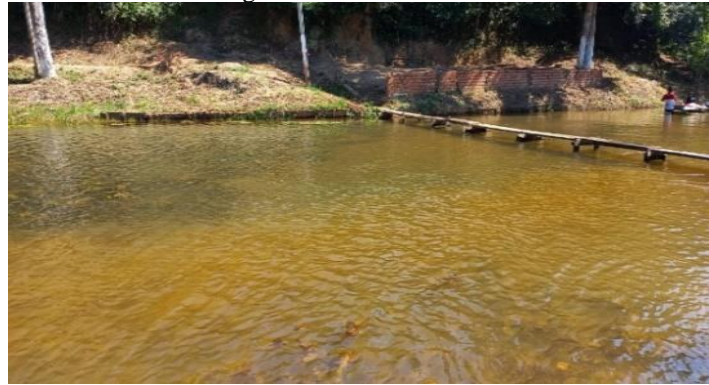
Figure 1 – Prainha do Jacu

As the concept of watershed was presented, it allowed the professor to show some examples of local micro-basins or subsystems close to the campus of the Civil Engineering Course, such as the one on the Açailândia River, which is located in the Jacu neighborhood (figure 1), a region that favors the use of learning schemes located in its memory. acquired during their life experiences.

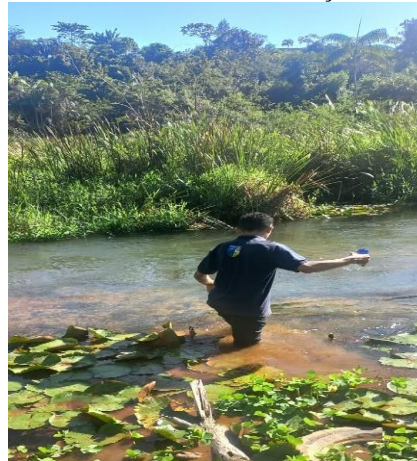
Figure 3: Water collection in the Açailândia River

During the realization of this work, a partnership was achieved with IFMA (Federal Institute of Maranhão) of the Açailândia campus, which was responsible for analyzing the quality of the water in terms of bathing (water suitable for bathing). Then, there was a collection at three points of the Açailândia River, one near Juazeiro Street (figure 3), where an environmental awareness project took place, and the other two further upstream, Prainha do Jacu, in the Jacu neighborhood and the Yasmim resort in the Colina Park neighborhood. The objective would be to understand the flow of pollution that moves through the waters of the river and observe the local nature and its possible pollutions.

This local bathhouse (sample 1 and 2) was one of the first water collection points, in addition to Prainha do Jacu (sample 3 and 4) and Yasmin bathhouse (sample 5 and 6) in the vicinity of the same river, totaling six samples, two from each location. These samples were analyzed by the IFMA-Açailândia laboratory (see figure 4), the test was for thermotolerant fecal coliforms, which gives the result if the waters are suitable for bathing or not.

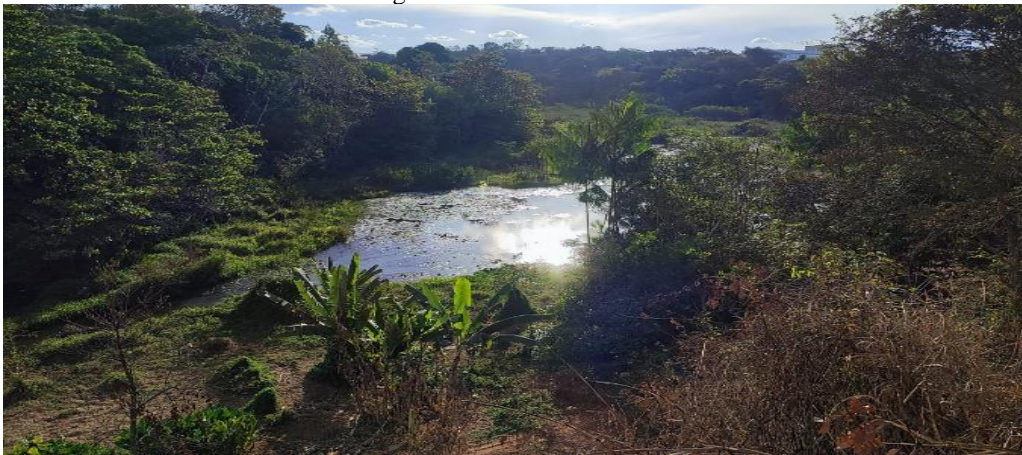
Figure 4: Culvert bathhouse

After the conclusion of the course of the discipline of Hydrology together with the completion of the Environmental Education project, the professor and some students decided to investigate more deeply some sources of water pollution in the region of the first collection (sample 1 and 2), known as the bueira bath (see figure 4), a bathhouse that was once very popular in the region by the population of the municipality. In the period of the 90s, which in recent years has been suffering the impacts of pollution, silting and abandonment by the municipal government. In this sense, a second questionnaire was made with questions passed to residents near the locality on August 15, 2023, in an attempt to investigate new sources of pollution in this region and perhaps propose solutions.

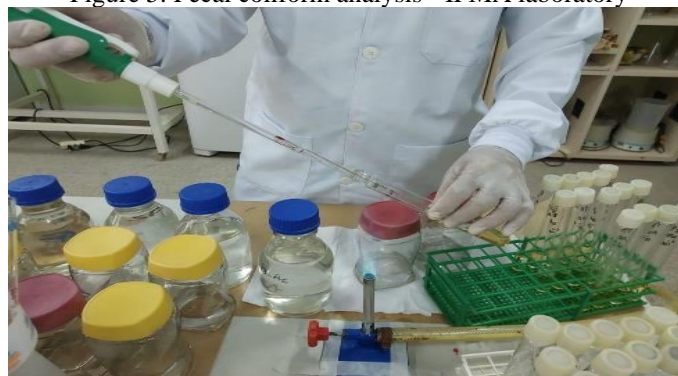
Figure 5: Fecal coliform analysis - IFMA laboratory

This technique consists of identifying the coliform bacteria that constitute the most used contamination indicator worldwide, being used as a basic bacteriological parameter in the definition

of standards for monitoring the quality of water intended for human consumption, as well as for characterization and evaluation of water quality in general. The objective of the thermotolerant test is to observe whether the water presents gram-negative, aerobic or facultative anaerobic, non-spore-forming bacilli that ferment lactose with acid and gas production in 48 hours at 35°C, as shown in the figure below.

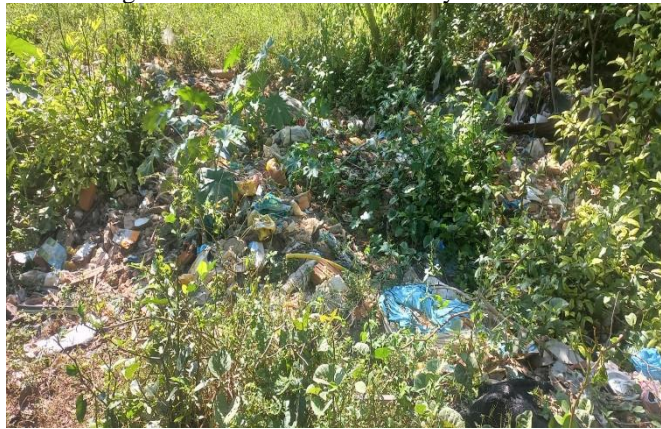
Figure 7: Plastic waste carried by the current

relation to the other collection points, where many foci of plastic and organic garbage carried by the river current to this point were found. (See Figure 7)

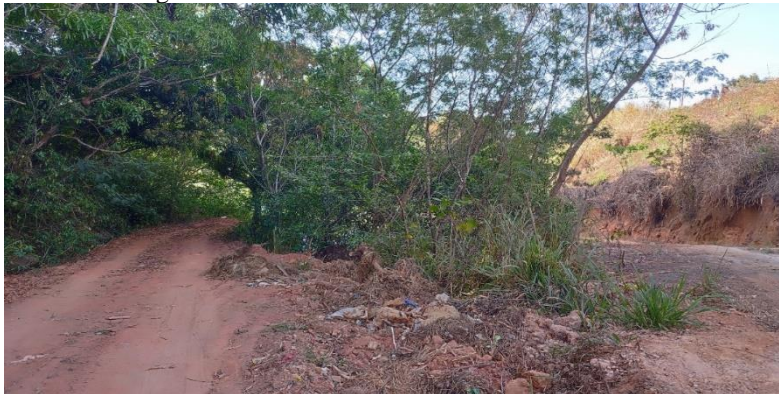
Figure 13: Entrance area of the culvert bathhouse

This replacement of natural protection zones around the resort can contribute to the increase of rainwater that may usually carry sewage, debris and landfills by rainwater, as we can see in the image

below, at the entrance of the resort where the local municipality deforested and landfilled a permanent protection area (APP), for the permission of entry of water trucks.

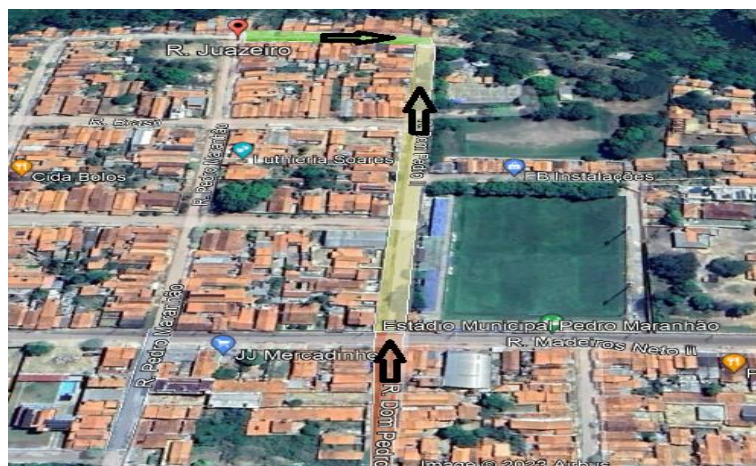
Figure 16: Intersection of water flow from Dom Pedro Street and Juazeiro Street at the intersection point where the erosion is located

Another observed point of accentuated movement of rainwater is Dom Pedro II Street, which also receives a large amount of rainwater from the street above (Dom Pedro I Street) and from its own extension, meeting at the end with Juazeiro Street, which as already seen in this work, favors a large movement of earth that in turn flows into the stream below.

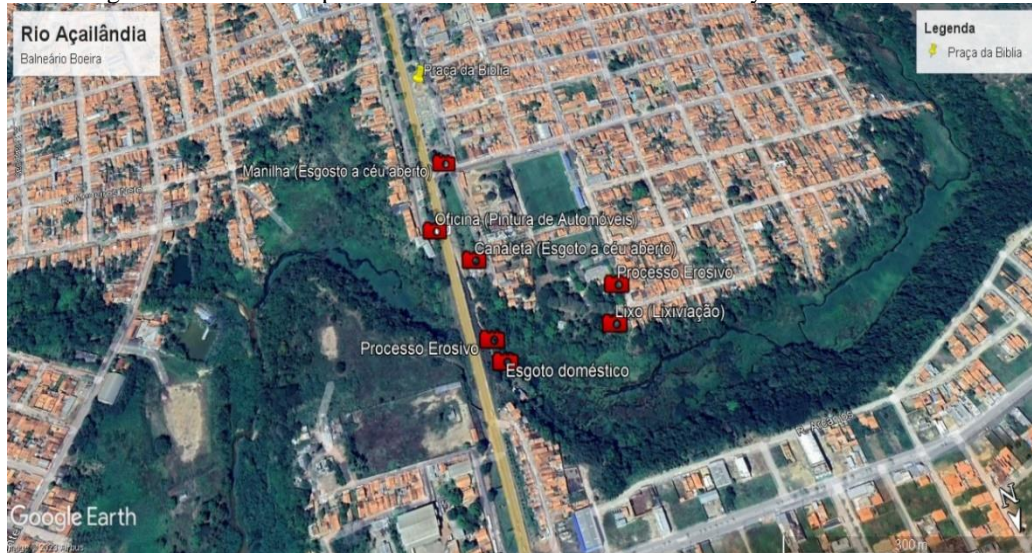
Figure 21: Sources of pollution found on BR 010 in the vicinity of the Bueira bath

In addition to these sources of environmental pollution, produced by local residents, at other points along the BR 010 highway, there are other sources of contamination that could contribute to an increase in the level of fecal coliforms and other polluting substances.

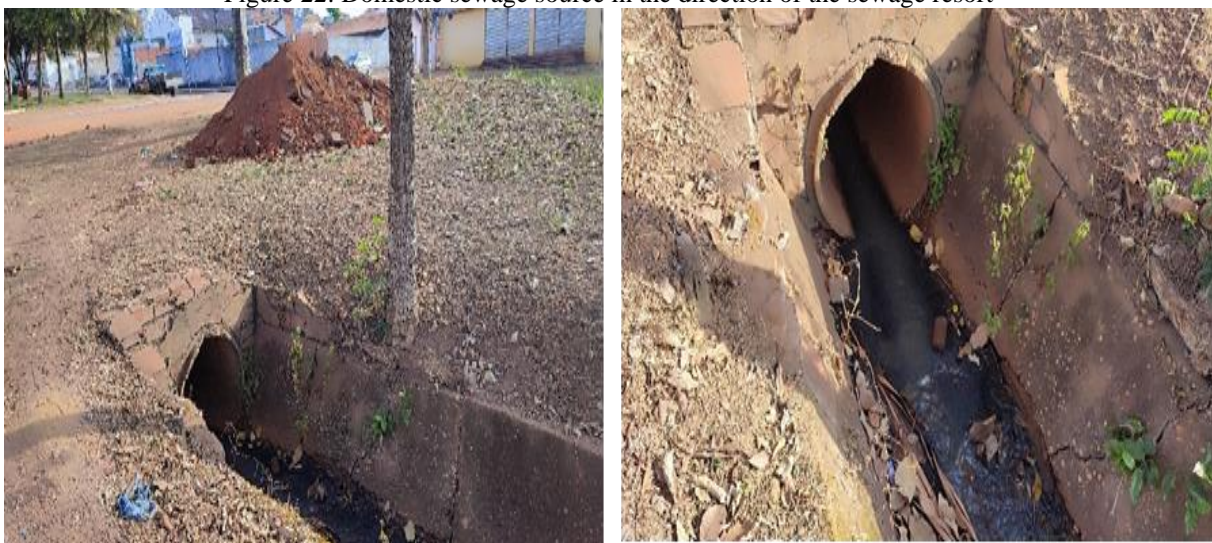
Figure 22: Domestic sewage source in the direction of the sewage resort

One of these foci is the domestic sewage from homes and businesses located near the Bible Square dumped directly into the street, with this, all liquid effluent travels to lower areas of the neighborhood that reach the river. In the photos it is possible to identify that from this point on the sewage travels through uncovered channels containing sludge, strong odor and dark color (figure 22).

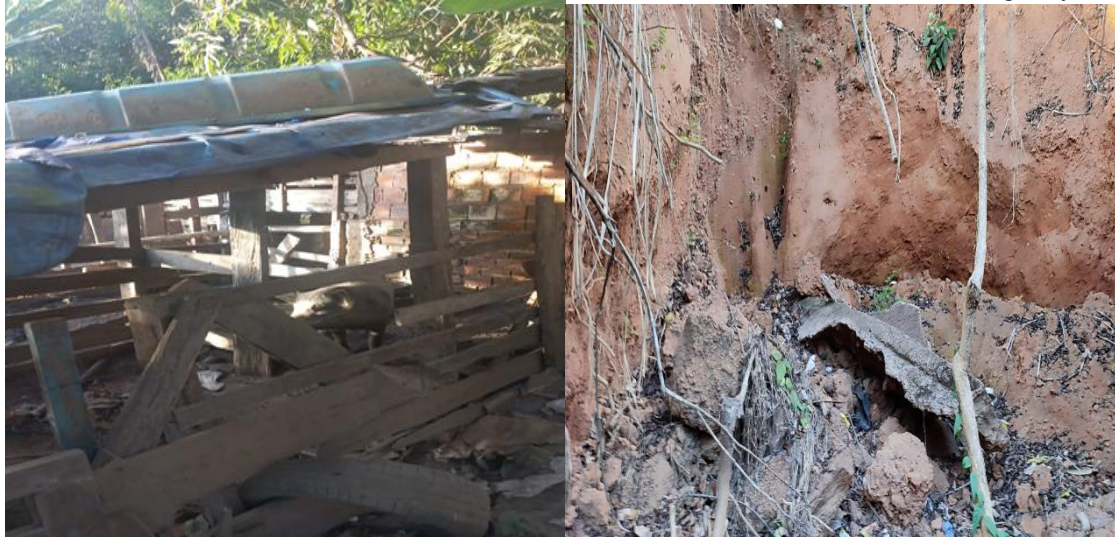
Figure 23: (a) pig farming near the river; (b) erosions found on the banks of the BR010 highway

The vicinity of the river still has pig manure, located at the entrance of the resort, generating substances harmful to the water such as sulfuric gas, ammonia and organic substances, contributing to

the process of eutrophication and new erosion on the banks of the BR 010, due to the deficiency of rainwater drainage that drains directly through old and unmaintained channels towards the river.
