## The impacts caused by drainage channels in wet areas of the Gravataí River – Rio Grande do Sul - Brazil and in Praia da Coronilha – Rocha – Uruguay

### ABSTRACT

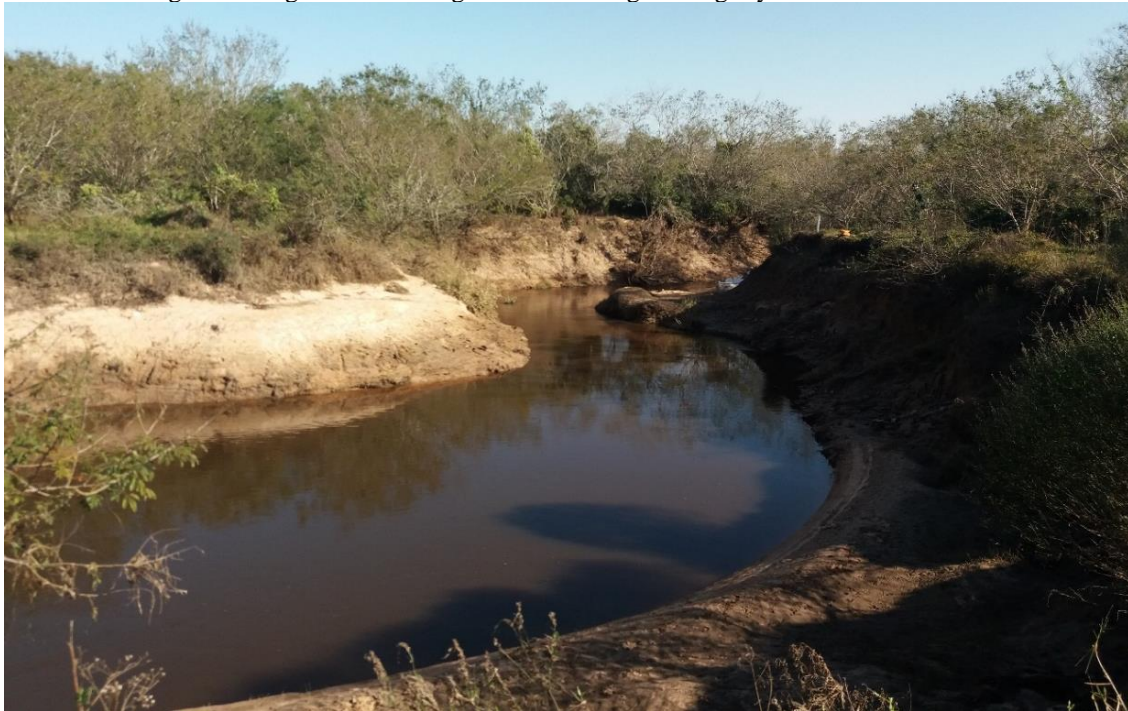
The physical characteristics of the groundwater flow (RUBBO, 2004) and periods of high precipitation that cause flood pulses (SIMIONI, GUASSELLI and ETCHELAR, 2017) become an agent with erosive potential, once the gully begins. It should be noted that, regardless of the precipitation regime, there is a permanent flow of water in the gully gutter, even during dry periods. The water table resurfaces at all times of the year, typical of wetland areas. As a result, there is a continuous dragging of sediments, where in periods of high precipitation the dragging of soil particles intensifies. The advancement of the gully may be associated with groundwater dynamics, as the flow of the water table inside the gully maintains continuous erosion of sediments (ETCHELAR, 2017). Figure 5, with an image of the gully erosion process in Banhado Grande.

Figure 5 - Segment with the greatest widening of the gully in Banhado Grande.

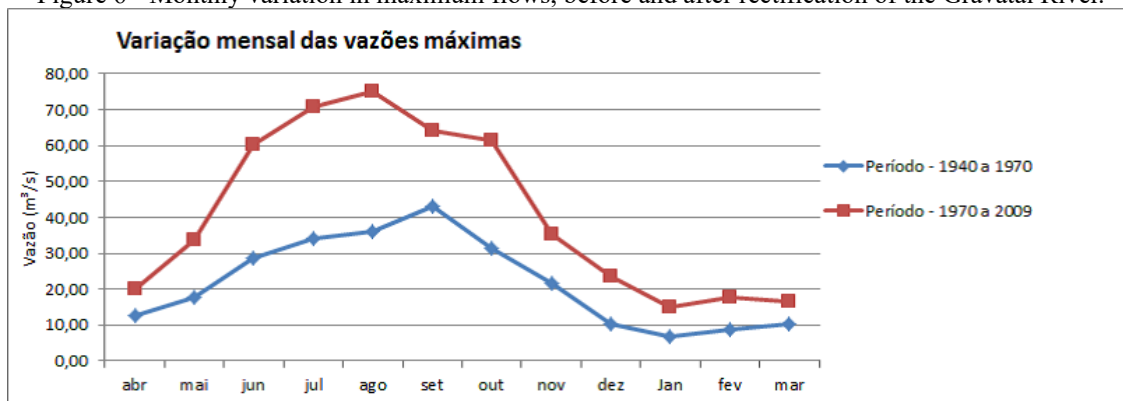
According to Belloli (2016), the analysis of maximum monthly flows Figure 6, between the years 1940-2009, shows a large increase in flow values, especially between the months with the highest precipitation in the basin (June to October). The maximum flow recorded from the years 1940-1970 for the pre-rectification period was 42.89 m<sup>3</sup>/s, in the month of September and the minimum flow was 6.27 m<sup>3</sup>/s in the month of January. In the post-rectification period, from 1970-2009, the maximum flow recorded was 74.93 m<sup>3</sup>/s in September and the minimum was recorded in January, with 15 m<sup>3</sup>/s.

According to the author, the amplitude between the month with the lowest maximum flow (January) and the month with the highest maximum flow (September) was 36.62 m<sup>3</sup>/s. In the post-rectification period, the amplitude between the month with the lowest maximum flow (January) and the month with the highest maximum flow (August) was greater, 59.93 m<sup>3</sup>/s.

Figure 6 - Monthly variation in maximum flows, before and after rectification of the Gravataí River.

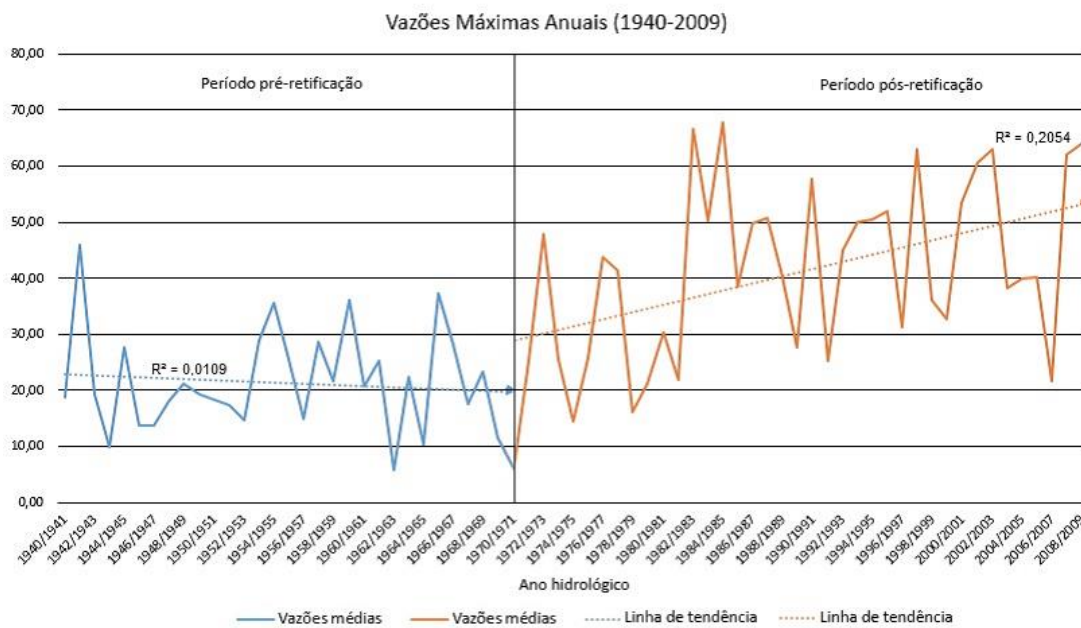
The analysis of maximum annual flows (Figure 7), according to Brenner (2016), shows a tendency for flow values to increase in the post-rectification period. Maximum flows increased due to the ease of flow provided by rectification, as the course of the river previously circulated a pattern of curves that dampened and reduced the flow speed and with rectification the straight course favored an increase in water flow speed. The highest value of annual flow found refers to the hydrological year 1984/1985 with 68.51 m<sup>3</sup>/s, while the lowest value in the series of maximum flows was found in the hydrological year 2006/2007 with 21.28 m<sup>3</sup>/s .

Figure 7 - Maximum Annual Flows for the period 1940-2009.

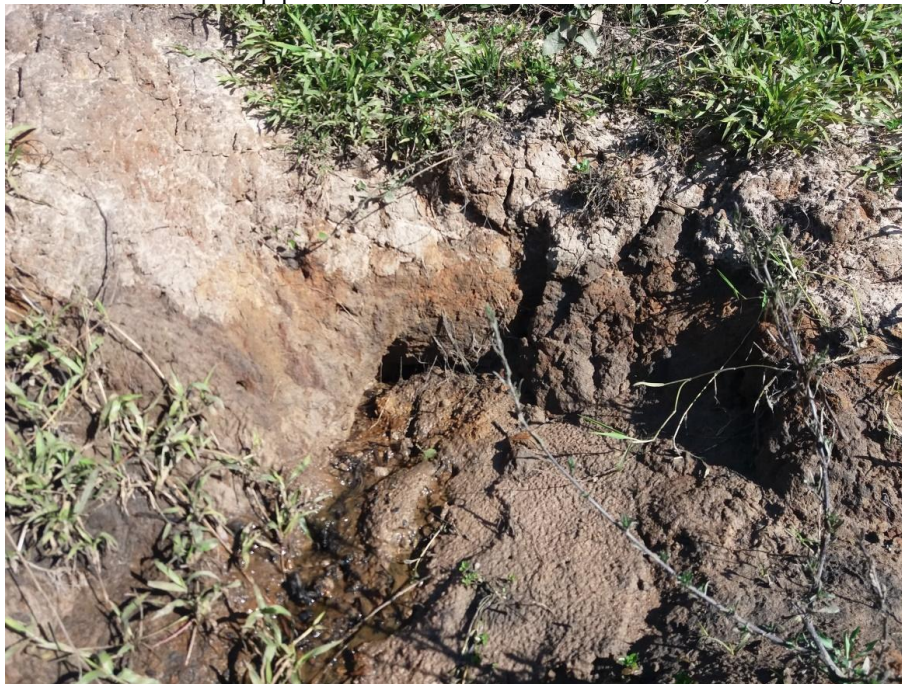
These subsurface erosion processes were identified in the wetland area, both on the slopes of the gully and on the slopes of the straightened section, as we can see a pipeline with water flow in Figure 8.

Figure 8 - Presence of an active pipeline with water flow on the riverbank, in the straightened section.

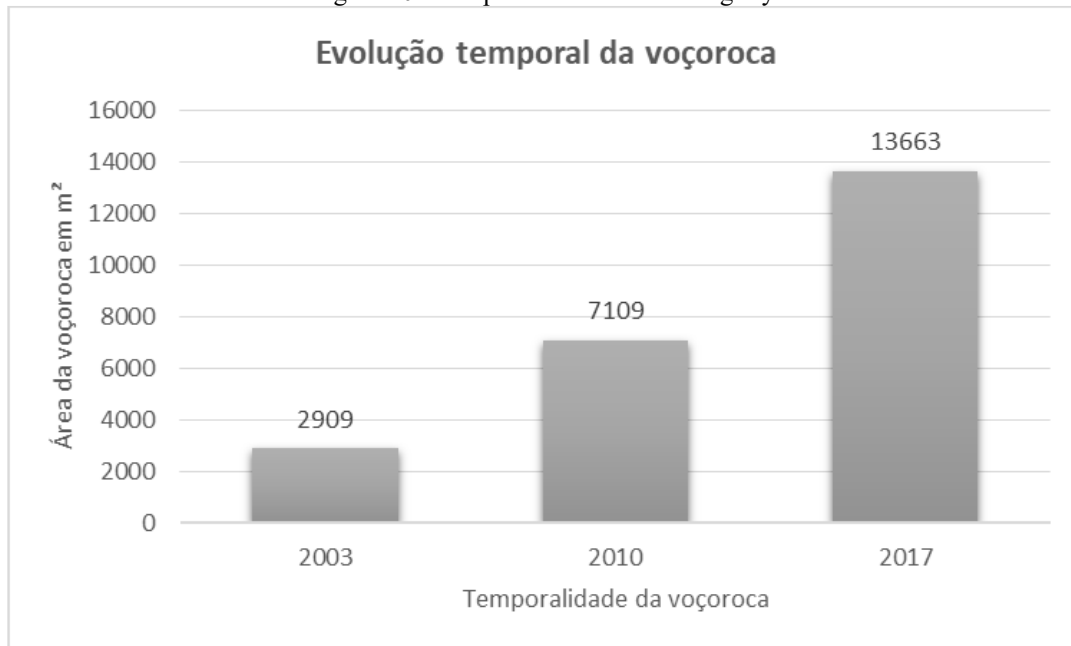
The time series of Google Earth images, in the analysis of the gully's features, made it possible to map and quantify the dynamics of the evolution of its erosion process. The eroded area increased from 2,909 m<sup>2</sup> in 2003 to 13,663 m<sup>2</sup> in 2017, Figure 10.

Figure 10 - Temporal evolution of the gully.

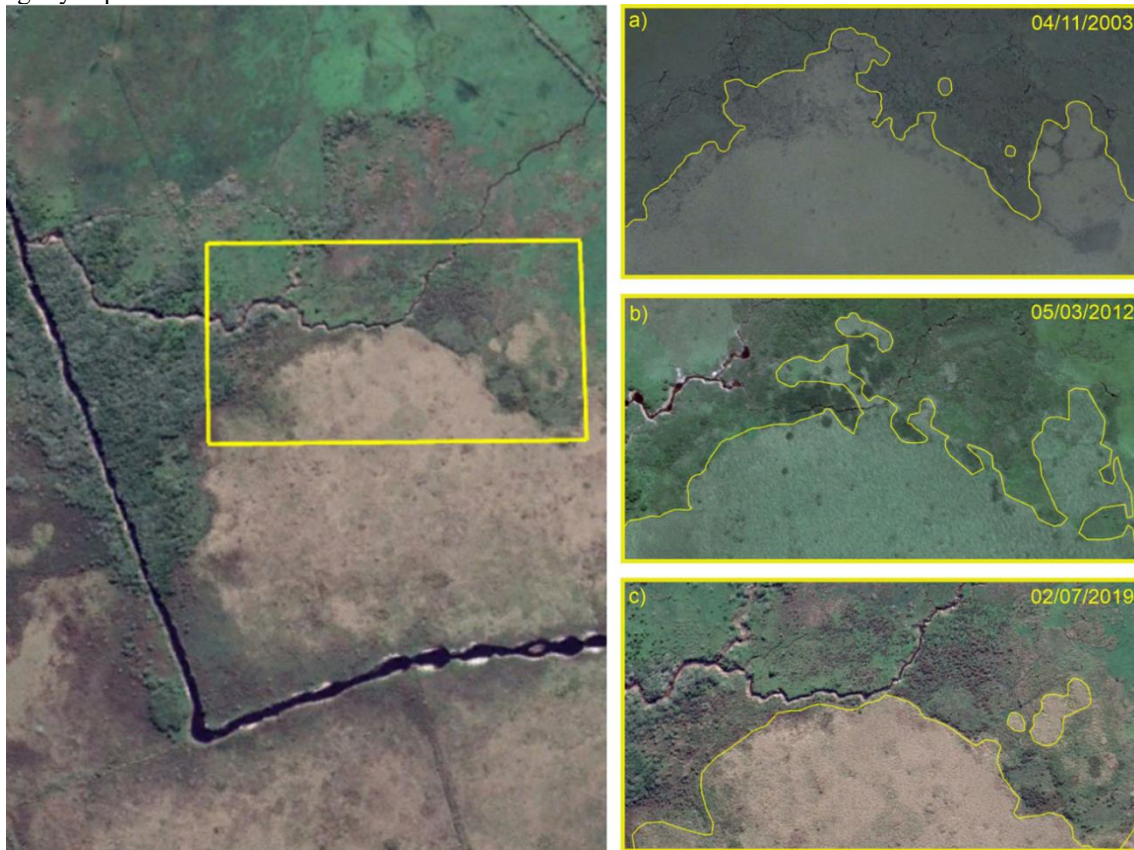
Through the visual interpretation of images for a time scale of the years 2003, 2012 and 2019, Figure 11, the impact that the gully causes on the typical vegetation of the wetland is identified. In the section upstream of the gully in the image: a) corresponding to the year 2003, when there is no presence of the erosion process; b) dated in 2012, the evolution of the gully and the retreat of vegetation can already be seen. In 2019: c) the gully reaches a stage that isolates part of the vegetation, leading to its replacement by another type of vegetation.

Figure 11 - Temporal analysis of a gully area in Banhado Grande where the conversion of vegetation type is observed as a result of gully expansion.

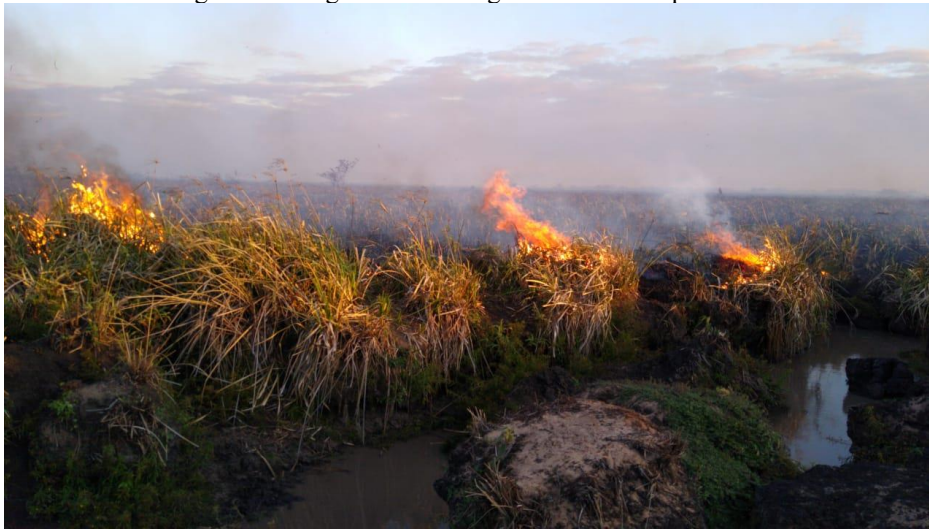
.Figure 17 - Vegetation burning at APABG in April 2020.

In April 2020, a large fire impacted Banhado Grande, as seen in Figure 17. One of the difficulties encountered in controlling this fire, in addition to difficult access, were the several fires that occurred in the subsurface in peat deposits. Peatlands have not yet been studied according to Accordi et al. (2003)

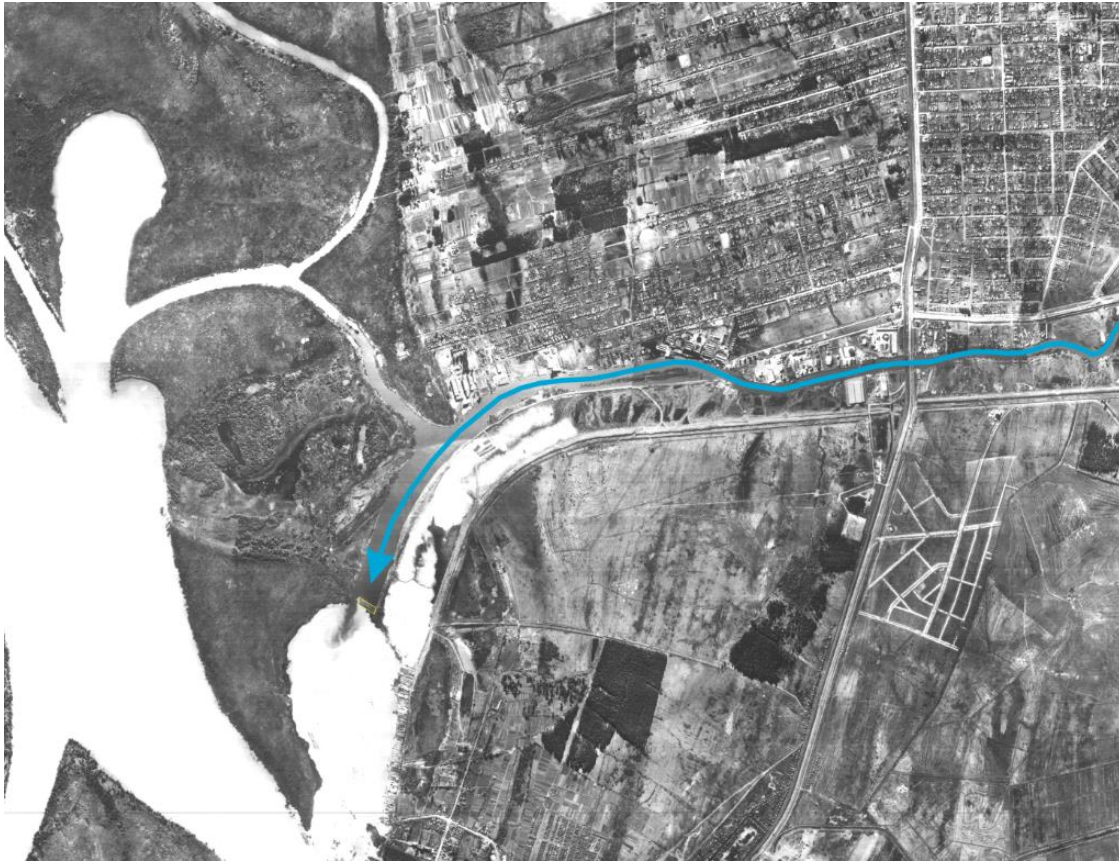
In Figure 20, from 1956, we can see the opening of the canal leaving directly to the south, cutting through the area called Humaitá, where the river started to flow into Saco do Cabral. In Figure 21, we detail that the canal in 1956 was not yet fully open. In Figure 22 we see the fully consolidated channel with its darker waters of the Gravataí River meeting the lighter waters of the Jacuí River.

Figure 20 - Image from 1956 that shows the incomplete opening of the channel that changes the mouth of the Gravataí river.

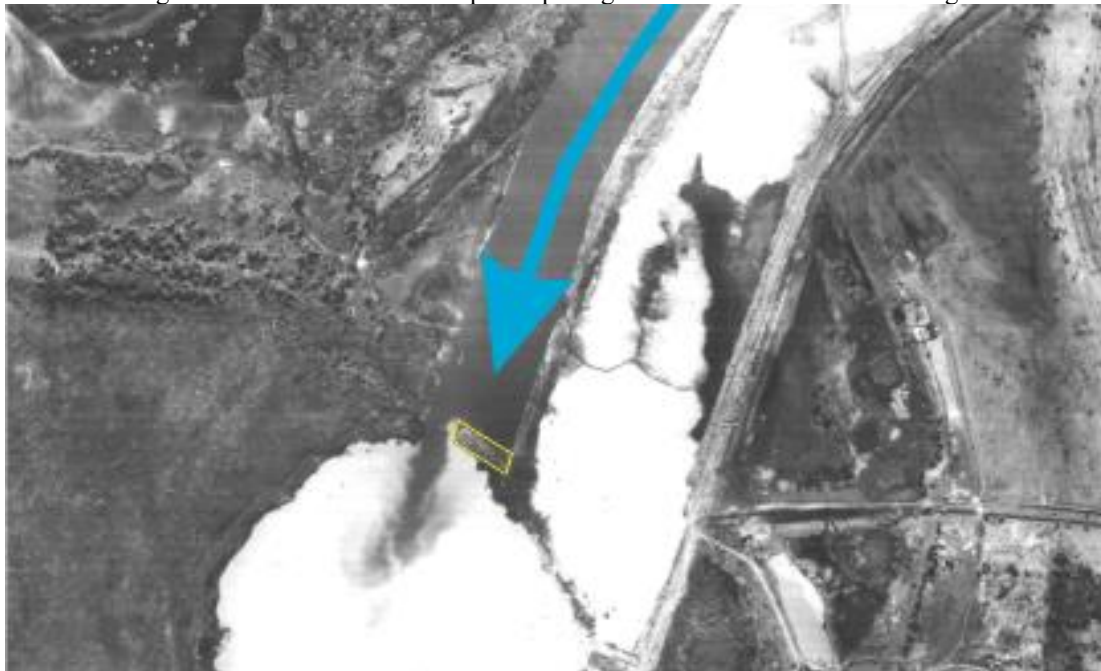
Figure 21 – Detail of the incomplete opening of the channel in the 1956 image.

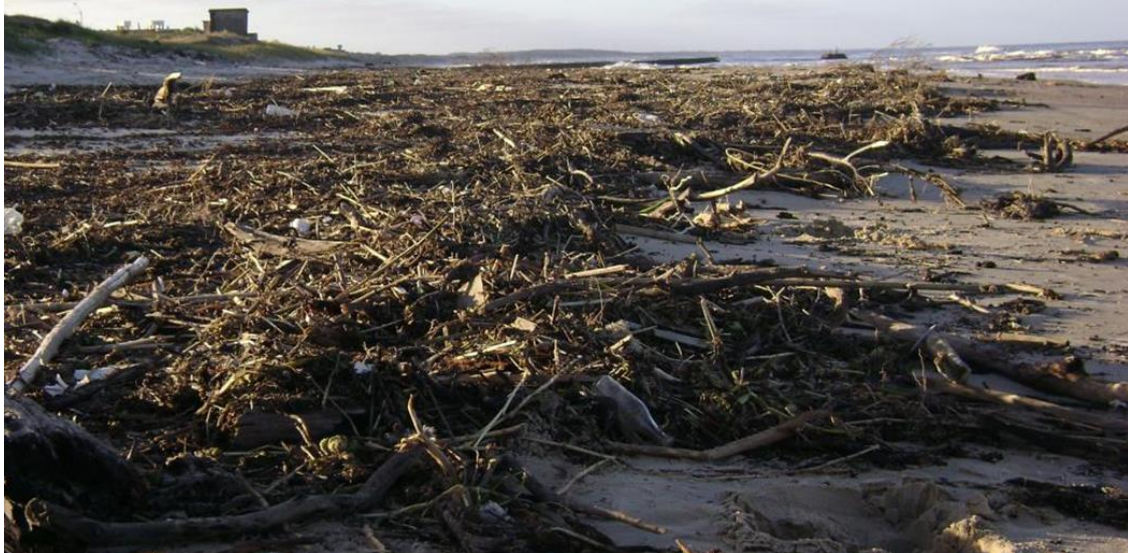
Figure 23 - Typical wetland vegetation on the edge of Coronilha beach – Uruguay.

In October 2019, with a large amount of plant debris that was coming out with the fresh water from the Andreoni channel added to the oceanic algae, it formed a kind of very dense blanket that did not allow the turtles to swim, and caused them to rush into this vegetation ( Figure 23). A similar phenomenon had already been recorded in 2012 and in 2016. The rescue was carried out in the Coronilla beach area (Figure 24), where there is a rehabilitation center that cleaned, hydrated and checked the physical conditions. Fortunately, this action managed to rescue all the turtles alive (URUGUAY VISIÓN MARÍTIMNA, 2019).
