**PATHOLOGICAL MANIFESTATIONS IN HISTORIC BUILDINGS: A CASE STUDY AT THE PATU HISTORICAL SITE, CEARÁ**

<https://doi.org/10.56238/sevened2025.008-022>**Ana Cláudia Vidal and Rérisson Máximo.****ABSTRACT**

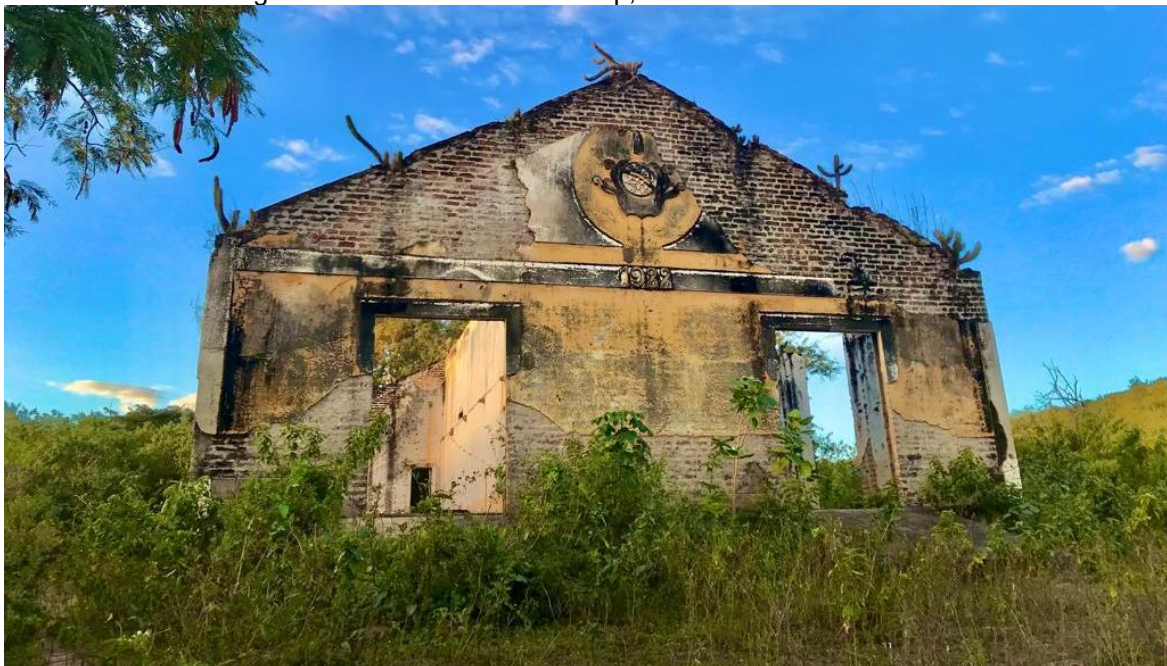
Figure 1 – Ruins of the Workshop, in the historic site of Patu

The ruins of the old train station (figure 1) are located on the banks of the Patu road. This place played a crucial role in the conformation of the historic site, as it was where the equipment and machinery used in the construction of the dam were received. During the drought of 1932, the Station also served as a landing point for drought victims arriving in the area. The station functioned as a depot for tools and supplies sent to the region. Although the railroad branch was deactivated and removed in the 1990s, it is still possible to find traces of it. The workshop, also known as Casa da Luz, housed equipment for the generation of electricity for the construction of the Patu dam. During the drought, it played an important role as a support point for the guards and for carrying out activities aimed at displaced people. A distinctive feature of this building compared to others is the presence of the national seal stamped on its façade.

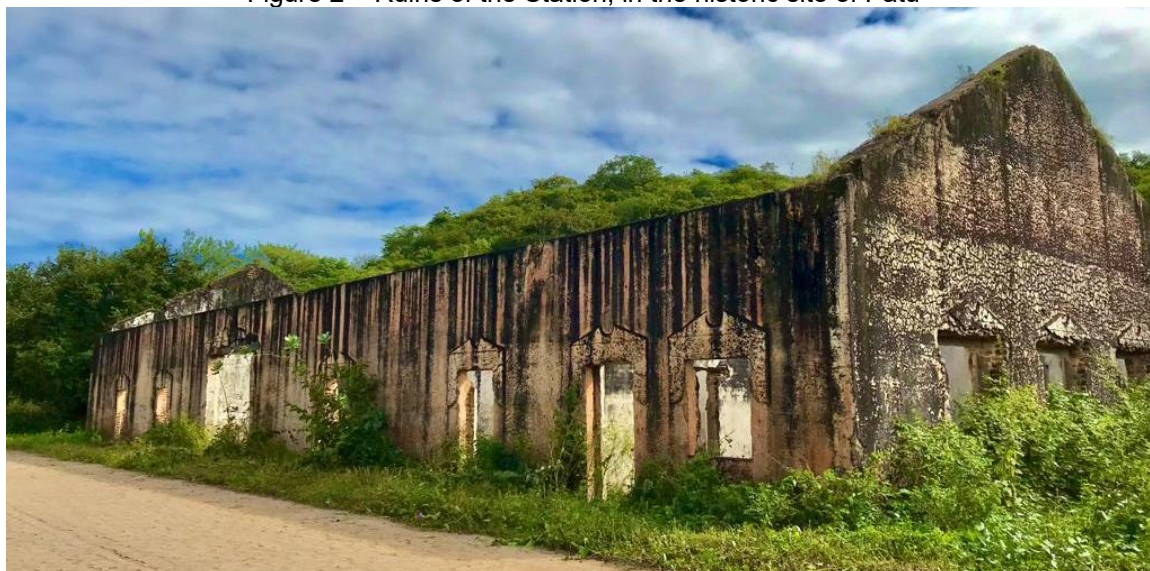
Figure 2 – Ruins of the Station, in the historic site of Patu

The station building (figure 2) was divided into 10 facades, comprising 4 external and 6 internal, mapped and identified in a floor plan with the location of each of the facades for reference. Views were created from each of the facades, identified with the initial "E" for "station" and numbers ranging from 1 to 10 (E1, E2, E3, etc.). With these graphic representations in hand, the manifestations found were mapped, which were practically the same on all facades: mold, mapped fissures, cracks and detachment.

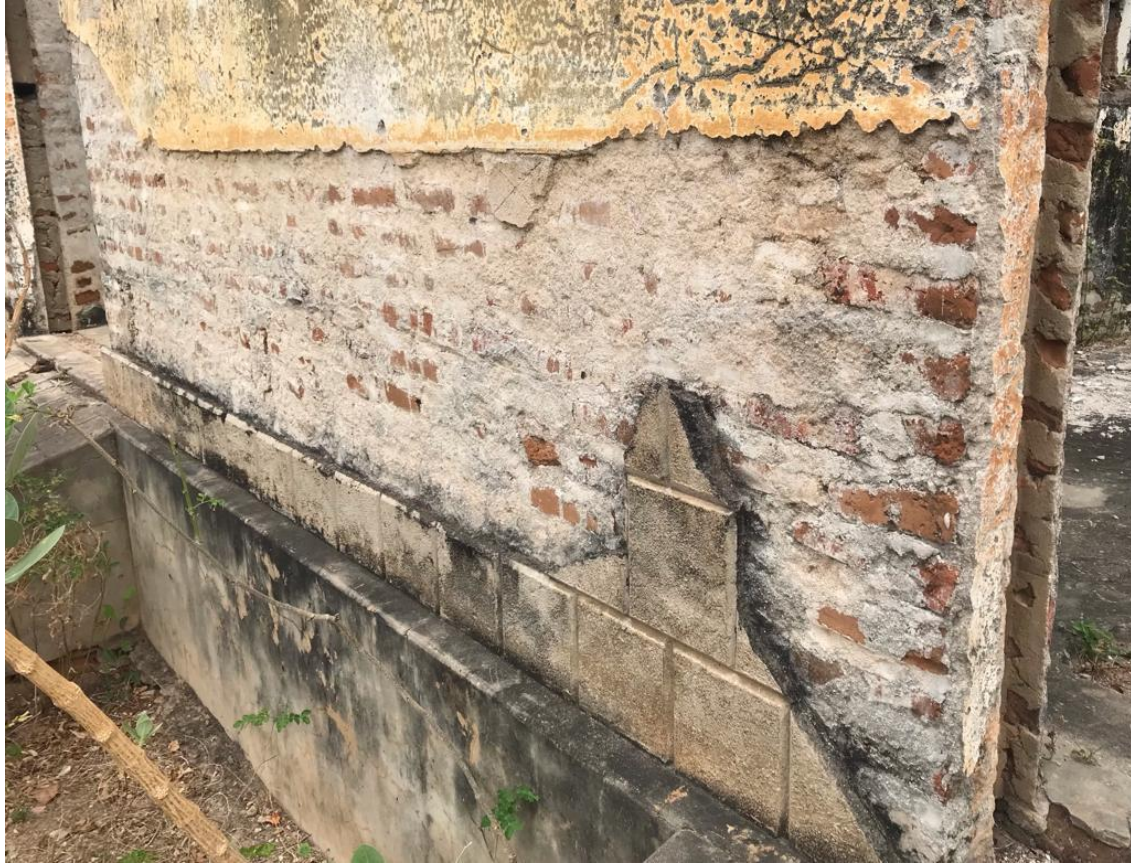
Detachment in mortar coating is a problem in buildings characterized by mortar boards that become rigid, brittle and detach from the surface. This can occur due to various causes, such as the presence of mica on the contact surface, the use of very rich mortars, thick layers of mortar, overly smooth base surfaces, hydrophobic substances at the base,

lack of roughcast layer, and thin mortars (Caporrino, 2018). In most old buildings, it was common to use adobe bricks, without the application of waterproofing, which made the material susceptible to damage caused by water, due to its high permeability.

Figure 5 – Detachment of the mortar coating

In some cases, coatings were found, such as chapisco, plaster and whitewash (painting with lime). One of the solutions adopted at the time was the construction of more extensive eaves to keep the water as far away as possible from the walls. Initially, the suspicion arose that the absence of chapisco was the cause of the detachment. However, after visits to the site, it was found that in an area affected by the landslide, there was, in fact, a layer of roughcast (figure 5). In the image, the presence of a thick layer of mortar is evident. The application of an excessively thick layer of mortar can result in detachment in slabs, since the great thickness generates distinct variations in expansion and retraction between the base and the coating.
