# Chapter 167

## Typological structural features of a stucco ceiling from the early 20th century: São Bento train station in Porto (Portugal)

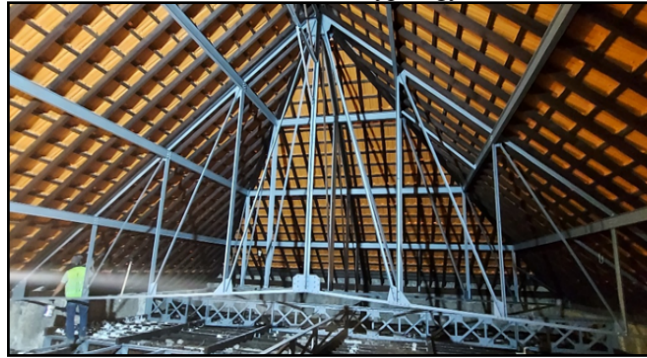
Figure 2 – Photo of the lattice metallic scissors with Pratt typology on the roof of the São Bento train station.

The building, which has a façade in granite stonework, features volumes with 2 volumes higher on the sides, consisting of 3 floors and a lower central body, with just one floor, where the main atrium takes place. The interior space of this last body, lined with tiles, is framed by granite moldings. The ground floor floors have ceramic material and screed and the remaining floors have parquet. The walls are made of stone masonry, in some cases plastered. The supporting structure of the ceiling results from a mixture of iron and wooden supporting elements, in an unusual symbiosis. On top of this structure, there are Pratt-type trussed metal trusses (typology mainly used to span large spans of up to about 30m), autonomous in relation to the roof support structure, which receive the purlins, the slats and the ceramic covering and support the load-bearing walls. atrium masonry. As a matter of curiosity, the structure of the passenger terminal's nave is also made up of metallic elements (pillars, rafters, purlins and braces in cast iron), in this case coated on top with corrugated plates of opaque and translucent material.

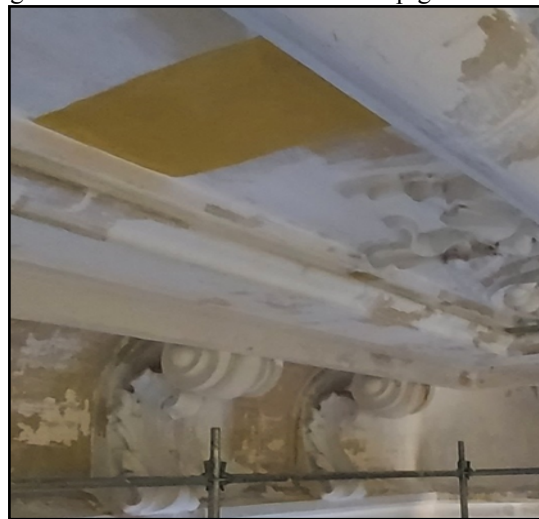
Figure 3 – Photo of the areas with the pigments found.

The stucco ceiling, present in the entrance hall of São Bento station, is slightly different from a short time ago, where before the ceiling was entirely white, highlighting only the words painted in black “Douro” and “Minho”, words these are directly related to the state-owned company Caminhos de Ferro do Minho e do Douro, responsible for building and managing the railway lines. Currently, the ceiling covering is in other yellow tones in some areas. This current color is the result of a discovery made during the recent restoration work, where layers of stucco in yellow and brown colors were found.

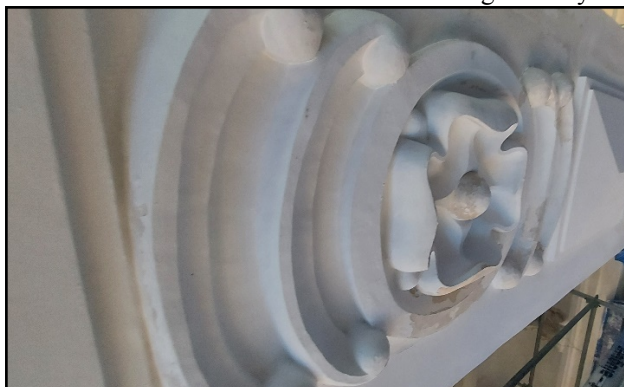
Figure 4 – Relief of the circle with the flower and the small rectangle that symbolize parts of the train.

According to information acquired through conversations with the specialist in stucco work Nestor Filho, yellow, in particular, is one of the most common colors found in plastered ceilings in the Minho region and, in the particular case of this building, yellow is also used. relates to the tiles, creating a contrast with most tiles in blue tone, but in common with the tiles in the range closest to the ceiling which are yellow and brown. Another very interesting information about the decoration of the ceiling, also shared by the expert, refers to the existing reliefs on the two beams that cut the ceiling and divide it into three parts. The reliefs on these beams are composed of two smaller rectangles, one at each end, followed by two circles, located a little further to the center of the beam and between them a larger rectangle. This set of geometric shapes symbolized the train, where the two smaller rectangles would be the locomotives, the larger

rectangle would be the wagon and the circles would symbolize the wheels, including a flower inside them, which was alluding to the company's symbol.

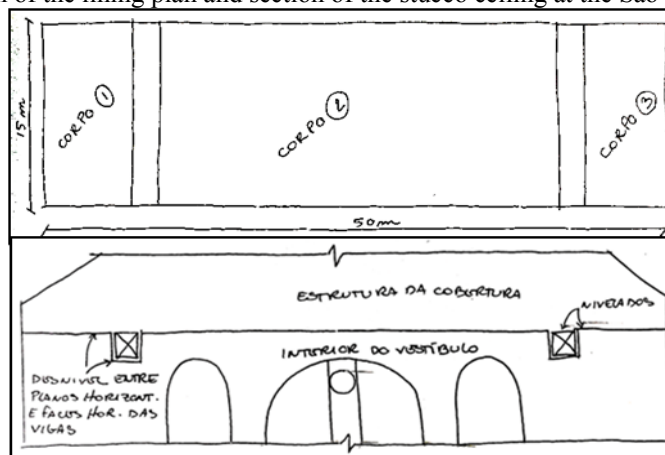
Figure 5 – Sketch of the lining plan and section of the stucco ceiling at the São Bento train station.

The volumetry of the ceiling is divided into three parts, separated by two iron beams protruding from the level of the planes, also covered with stucco. The structure of the planes and ceiling beams is leveled on the upper, uncoated surface.

Despite the ceiling being volumetrically quite simple, the monumentality of its proportions (13.73m x 42.97m) requires structural reinforcement that would be difficult to achieve using only wooden elements, as was usual. The support of the station's roof lacked elements with great resistant capacity to withstand bending efforts generated by the large span without intermediate pillars, but which, at the same time, ensured the necessary lightness and rigidity in order not to add significant additional loads (weight) and guarantee both the horizontality of the ceiling and the stability of the structure.

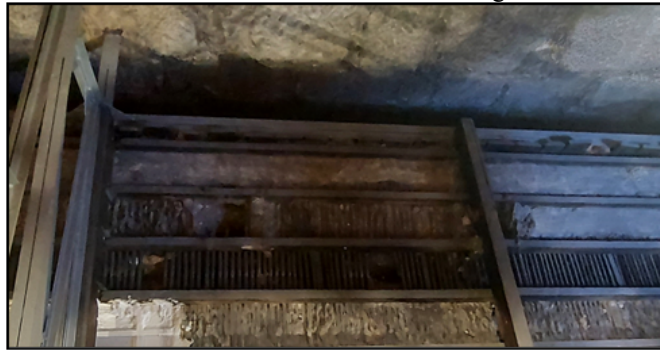
Figure 6 – Photo of the wooden structure of the stucco ceiling of the São Bento train station.

The supporting structure of the ceiling consists of a main set of metallic elements, which receives a secondary set of wood composed of primary, secondary and counter beams, this second set is responsible for supporting the lath mat, which receives the stucco mortar. .

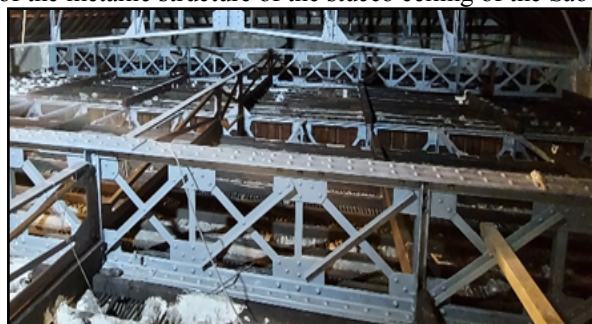
Figure 7 – Photo of the metallic structure of the stucco ceiling of the São Bento train station.

With regard to metallic elements, we find trussed beams of the first and second order and spatial trussed beams, both of the mullion composite type.

The spatial beams, which form the relief volumes that separate the three horizontal planes of the ceiling, are latticework on the lower and lateral faces, and are also of the “composed with mullions” type.

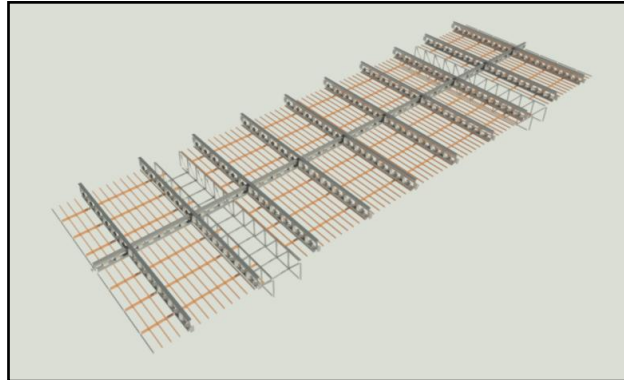
Figure 8 – 3D image of the stucco ceiling structure of the São Bento train station.

The main structure contains about ten primary trussed metallic beams, arranged in the direction of the smallest dimension (13.73m), supported by the masonry walls of the atrium. These ten beams support a large secondary trussed steel beam, centered, arranged in a transverse direction to the previous beams (42.97 m long). This beam, in the middle of the span, helps support the two spatial metallic beams, as they are positioned at a lower level than the others, so that they are not able to lean on the walls as effectively. Transverse to the main metal beams there are seven rows of wooden beams, and, transverse to these, there is another set of ninety rows of secondary wooden beams, which support the slats of the partition. Among the ninety rows of beams in the second set, there are some counter beams scattered in a not very uniform way, thus finalizing the distribution of the elements that make up the secondary wooden structure of the ceiling support. In some areas, the presence of staff boards can be observed, replacing the original partition, resulting from interventions carried out in the past.

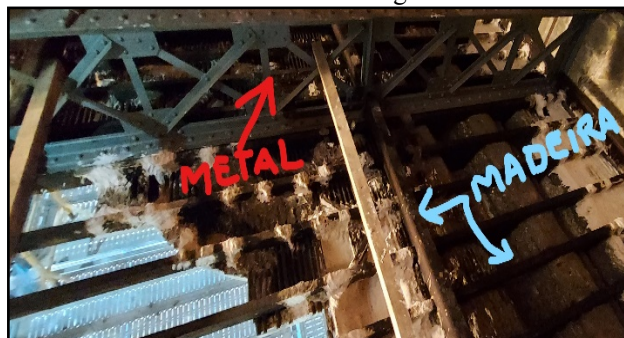
Figure 9 – Photo identifying metallic elements and wooden elements together on the stucco ceiling of the São Bento train station.

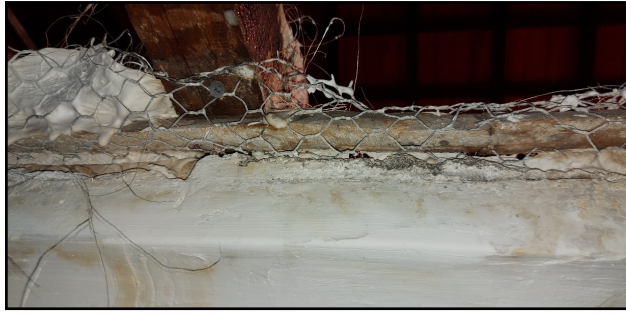
Figure 10 – Photo of the metallic mesh found between the lath and the cladding layers on the ceiling of the São Bento train station.

Between the fasquium and the embossed decorative elements, sisal was found mixed with the mass, which is already known to be a common practice. But, in addition to sisal, wire strands and a metallic mesh were also found, used mainly in the so-called strong mass ceilings (ceilings that, like the crate mat, fall into the category of special mats because they are unusual) (Costa, 1955).

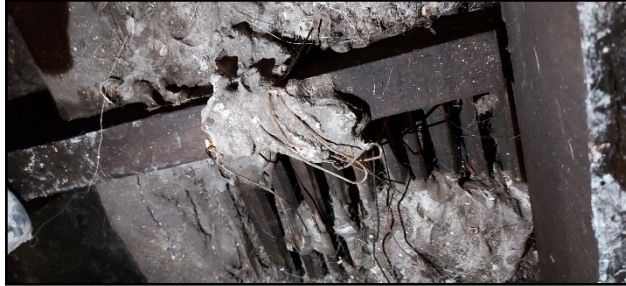
Figure 11 – Photo of the wires on the roof of the São Bento train station.

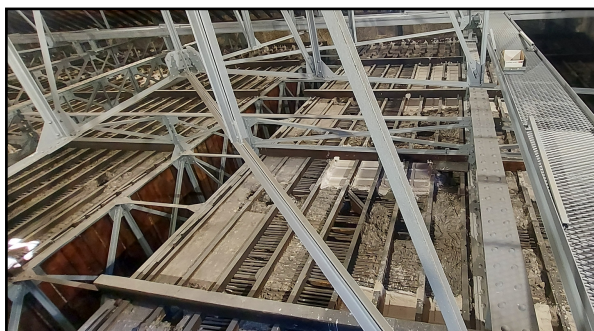
Figure 12 – Wooden elements in rectangular cut and use of new materials, present in the structure of the stucco ceiling of the São Bento station.

However, still with regard to the history of stucco development, it is during this same period that an improvement can be noted in the supports of these decorative coverings, through optimizations such as the use of wooden beams of rectangular section, which will have reduced the area to beam volumetry and consequently the amount of load it could support, but it brought a standardization of the parts and the improvement of the connection between the different structural elements. Aside from the change in the cut of the wooden structural elements, there was also the use of new materials, such as iron, a material so versatile that it showed excellent adaptation even in mixed structures, such as the one we were able to study in the case of the São Bento station, whose The state of preservation of the ceiling support is almost immaculate. Therefore, the technological advance identified in the support of the stucco lining of the São Bento train station, which also presents several industrial aspects, demonstrated a positive evolution, where the changes undergone brought excellent attributes within the structural function, which directly influence the preservation of the roof as a whole.
