Chapter 56

Inspection of pathological manifestations and map of damage on facades: case study in "Block C" of the polytechnic school of Pernambuco

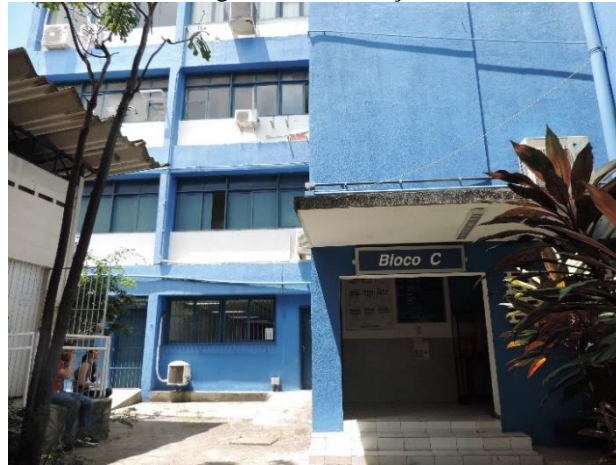
Figure 1 - Front façade

The front façade of block C (Figure 1) is the main access to the block, so it has a movement of students.
