## **Mapping of pathological manifestations in reinforced concrete beams: a case study in public school buildings**

This work focused on the mapping of pathological manifestations in exposed reinforced concrete beams, detected in some buildings of the Faculty of Science and Technology (FCT/UNESP), on the campus of Presidente Prudente, São Paulo. For this, a fieldwork was carried out, which consisted of obtaining digital images of the anomalies and annotation/recording in which each one of them is located. With the data, a table was elaborated that highlights the types of pathological manifestations present in the beams of each image, by means of geometric shapes of different colors with a legend. As for the pathological problems identified, the most common anomalies in the buildings are cracks and reinforcement exposure, showing how the absence of a maintenance and/or repair program for these structural elements can compromise both the aesthetics and the useful life of these buildings.

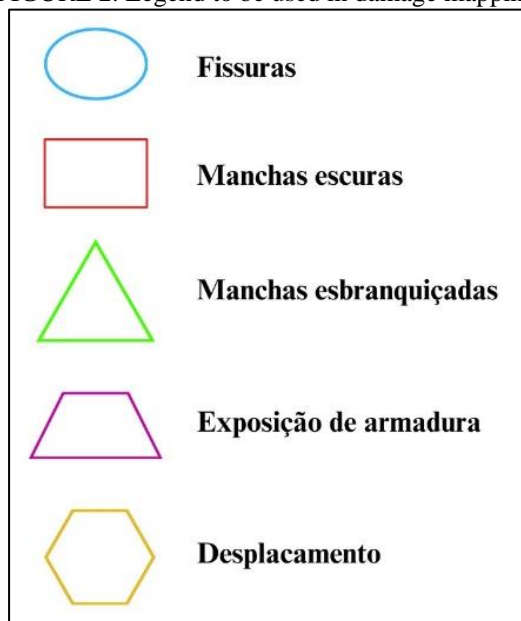
FIGURE 2. Legend to be used in damage mapping.

**3rd Stage:** Presentation of the mapping of the pathological manifestations identified in the beams, containing their general aspects. The mapping was presented using a legend, based on Silva et al. (2022), which identified each type of anomaly detected (Figure 2). A semi-professional Nikon camera (model COOLPIX P600) aided by an aluminum tripod was used at this stage. Regarding the level of inspection carried out, as in Silva et al. (2022), the classification presented by IBAPE (2012) was adopted, summarized in Table 1, in which the technical characteristics of the building are considered, combined with the maintenance and operation plan.

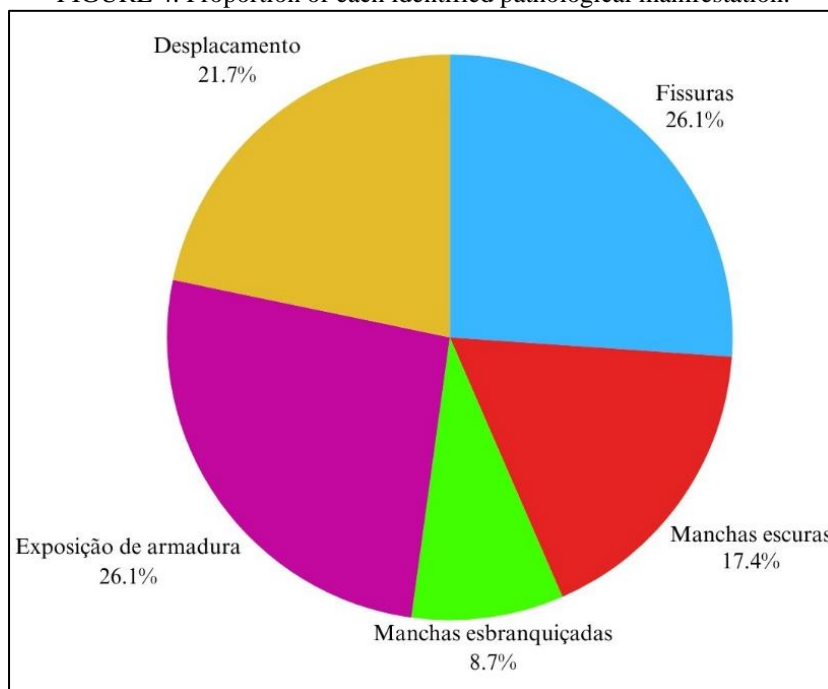
FIGURE 4. Proportion of each identified pathological manifestation.

Different pathological manifestations were identified in concrete beams of FCT/UNESP and, from the analysis of the data established in Chart 1, a graph was generated (Figure 4) which indicates the proportion of pathological anomalies identified in the buildings under study.

In view of this, it can be seen that Figure 4, with the exception of whitish spots, the proportion among the anomalies detected in the buildings is relatively similar, which can highlight the cracks and the exposure of reinforcement, which appear more frequently.
