## Study of the mechanical properties of repair of AISI 1020 steels with a composite based on polymeric adhesive and carbon fiber

### ABSTRACT

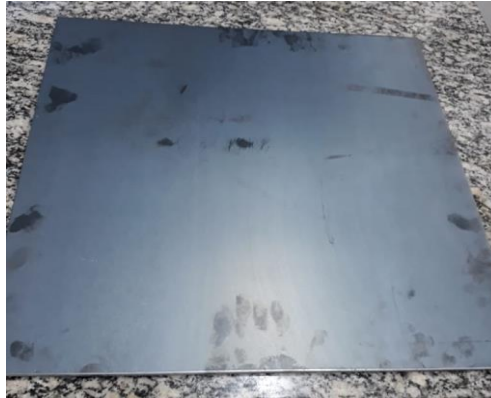
In this work, samples of two steels was used, AISI 1020 with a thickness of 4mm (5/32"). This material was donated in the form of a plate to be worked on, as shown in figure 1.

Figure 1 – 1020 Steel Plate used in this research, as received. Source: The author, 2023

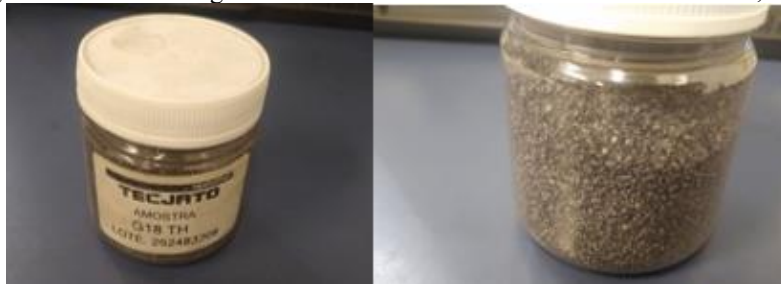
In the process of adhering the metallic material to the composite, a steel shot blasting step was necessary, causing it to gain greater roughness on the surface in contact with the adhesive, making better adhesion possible. Figure 2 refers to the shot blasting sample used in the process.

Figure 2 – Shot blasting G18 TH and Lot: 262483208. Source: The author, 2023.

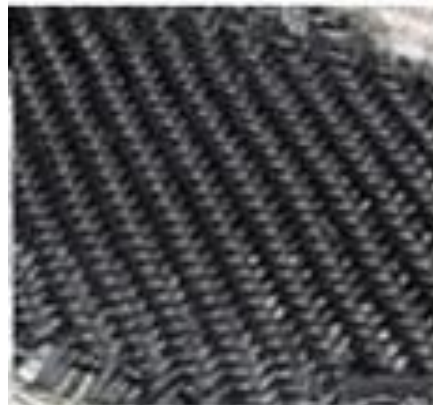
It is used to reinforce 45-degree bidirectional carbon fiber fabric as reinforcements for the adhesive. These reinforcements were chosen based on literature and suggestions from steel suppliers. Figure 3 shows the carbon fiber applied in the repairs.

Figure 3 –Carbon fiber fabric used in this work. Source: The author, 2023.

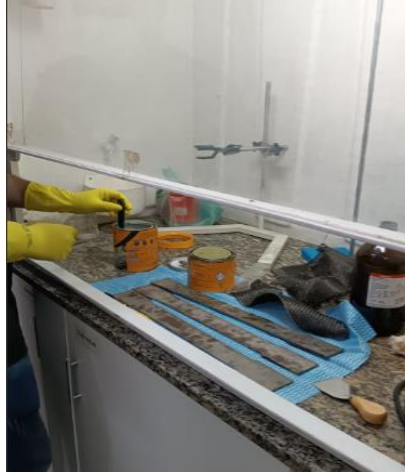
In addition to the materials mentioned above, a metal spatula with a wooden handle, a small brush for homogenizing and distributing the adhesive on the samples, and acetone were used to clean them. PPE, gloves, mask, safety glasses, and lab coat were used, and the adhesive was handled inside the fume hood to avoid inhaling organic vapors and odors from the adhesive, as shown in figure 4.

Figure 4 - Handling of the adhesive was carried out inside the fume hood. Source: The author, 2023

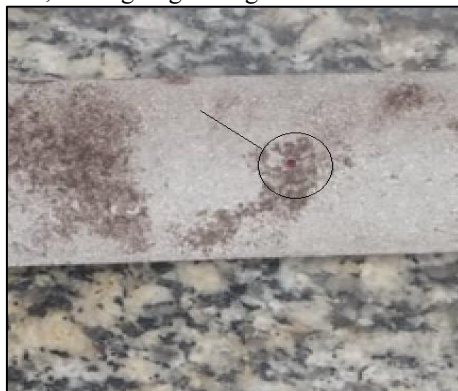
The damage caused was two types of holes, going through the entire thickness of the material and holes up to 50% of the thickness of the steel samples. Figure 5 shows a sample. To repair the defect caused in the steel samples, a medium fluid epoxy-based structural adhesive was used, adding carbon fiber fabric for reinforcement with a bidirectional weave at 45 degrees.

Figure 5 - Damage caused, holes going through the entire thickness. Source: The author.

The AISI 1020 steel samples with defects, as mentioned previously, in the form of holes produced with different thicknesses up to 50% and holes up to 100%, crossing the entire thickness with a 2mm diameter drill. The material's substrate surface was prepared at the Industrial Processes and Nanotechnology Laboratory (LPIN), at the State University of Rio de Janeiro on the West Zone Campus of Rio de Janeiro (UERJ-ZO).

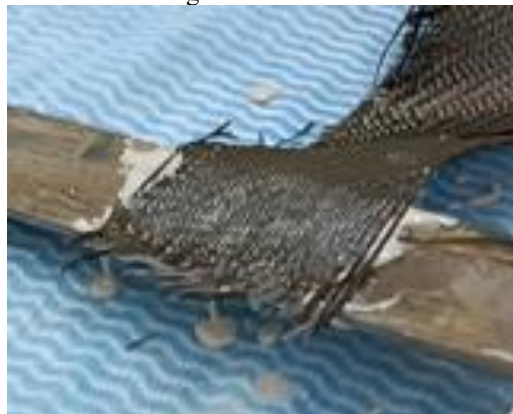
Acetone was used to remove impurities, such as oil, grease, and dirt, among others, and to clean the metal surface. The adhesive consists of two components (A and B) which come in cans joined by a plastic strip and which, once the packaging is opened, are mixed and must be homogenized using a spatula or mechanical mixer until obtaining a grey color, according to the manufacturer's instructions. Using a brush, the adhesive was applied to the defect region with a layer of approximately 1mm, a layer of fiber, fabric was applied to the adhesive, and then another layer of adhesive and another layer of fiber were applied. Figure 6 shows the fiber application process.

Figure 6 - Application of the adhesive together with the carbon fiber. Source: The author, 2023.

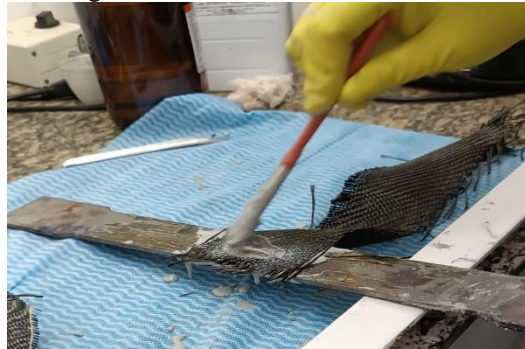
Despite the small size of the hole, it was decided to apply the adhesive over a wide area to better ‘hold’ the region around the hole, providing greater security in the repair, with a total of two layers of adhesive and two layers of fiber. Figure 7 shows the Application of the adhesive together with the carbon fiber on the other layers. The adhesive used has a relatively short pot life, becoming extraordinarily viscous and difficult to apply after approximately 20 to 30 minutes.

Figure 7- Application of the adhesive together with the carbon fiber on the other layers. Source: The author, 2023.

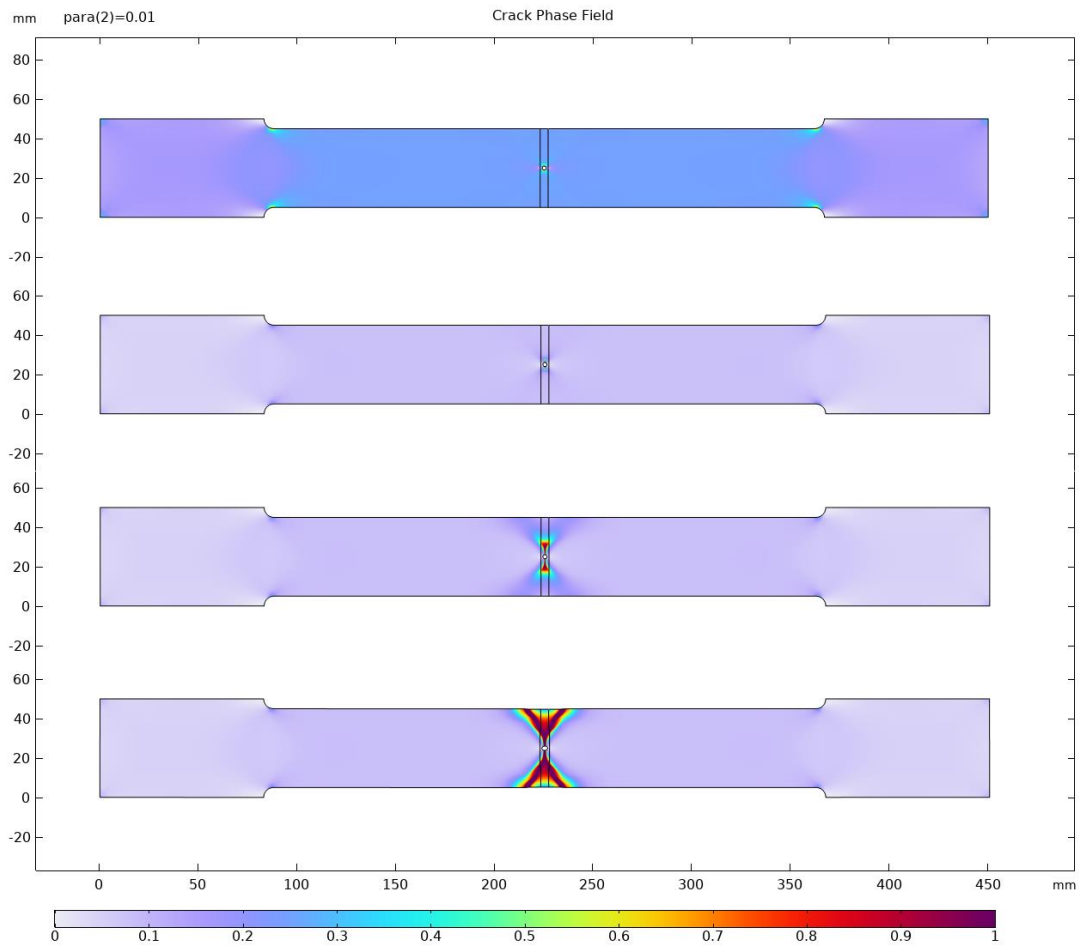
The next example studies the fracture of specimen in the model, including dimensions and material properties as the plate is loaded, a mixed-mode fracture is induced with a crack propagating from the predefined placed hole in the center. Fracture is modeled using a damage model that regularizes the sharp geometry of the crack by the phase field approximation. This means that the crack is described in the domain material, so the non-local phase field makes the crack path independent of the mesh elements. The example shows how to define an efficient and stable solver configuration for the phase field damage method.

Figure 12 presents the results of the numerical modelling that describes the fracture process in the elastic body from its nucleation to the propagation and branching of cracks.

Figure 12 - Crack phase field evolution for different step times. Source: The author, 2023

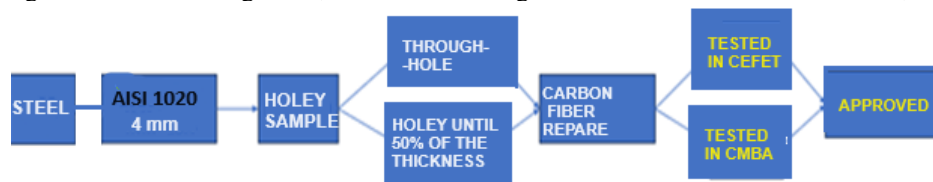
Figure 14 presents a general flowchart with the main stages of this work, such as receiving steel samples, creating the defect using machining, repair with the composite, tests and test results.

Figure 14 – flowchart general, with the main stages of this work. Source: The author, 2023.
